# **464 Golf Club Road** **‘Gay Farmhouse’**

## **Inspection Report**

**City of Fredericton Planning & Development**

**Ace Engineering Inc.**  
Fredericton N.B.

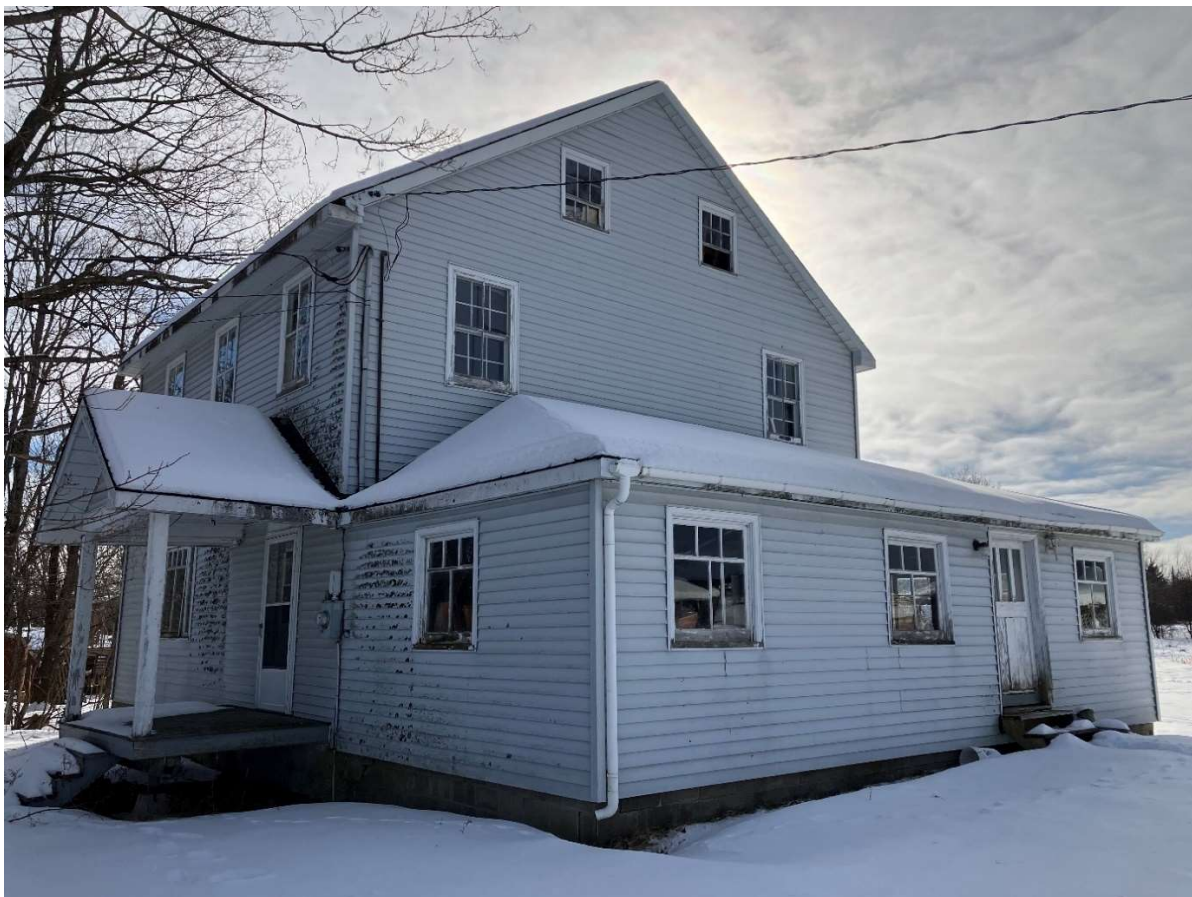
Figure 2-1: Farmhouse Exterior (Looking Southeast)

The existing Farmhouse structure is 2 storeys high with a finished attic space and unfinished basement. The roof is a gable style with asphalt shingles. The footprint is approximately square with a front covered porch. There is an enclosed west side porch supported on a masonry block foundation that appears to be constructed as an addition to the original Farmhouse. The porch roof framing is hip styled and supported by the exterior wall of the original Farmhouse. It appears that the original (or near original) siding was cedar shingles based on the exposed area below the porch roof framing. The remainder of the exterior cladding is vinyl siding.

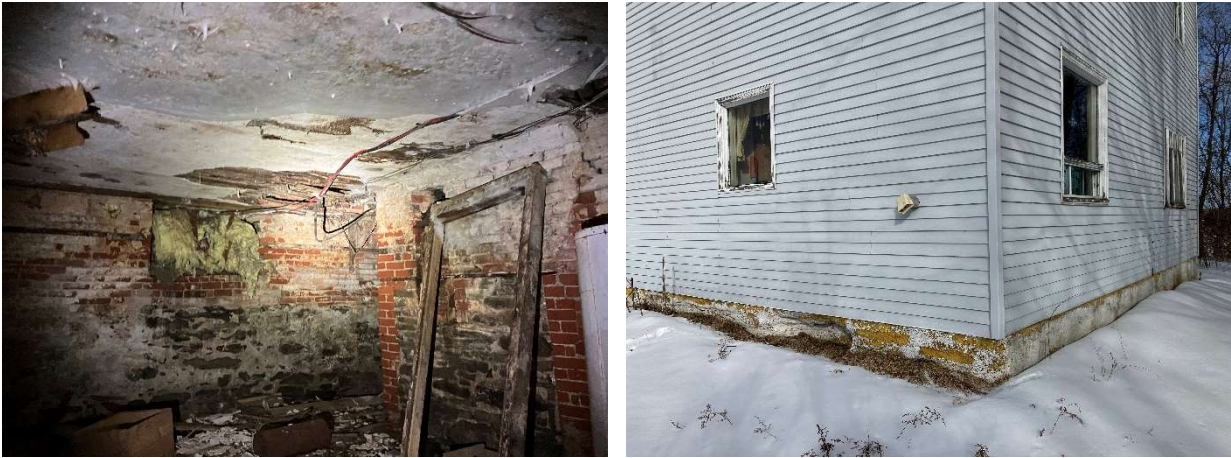
Figure 2-2: General Foundation

The original wood framed Farmhouse structure is supported by a red brick masonry wall constructed over a natural rock foundation with a dirt floor basement. The above grade exterior sides of the foundation wall have been treated with an unidentified type of spray foam insulation. There is an interior wooden staircase that allows access to the basement from the main level.

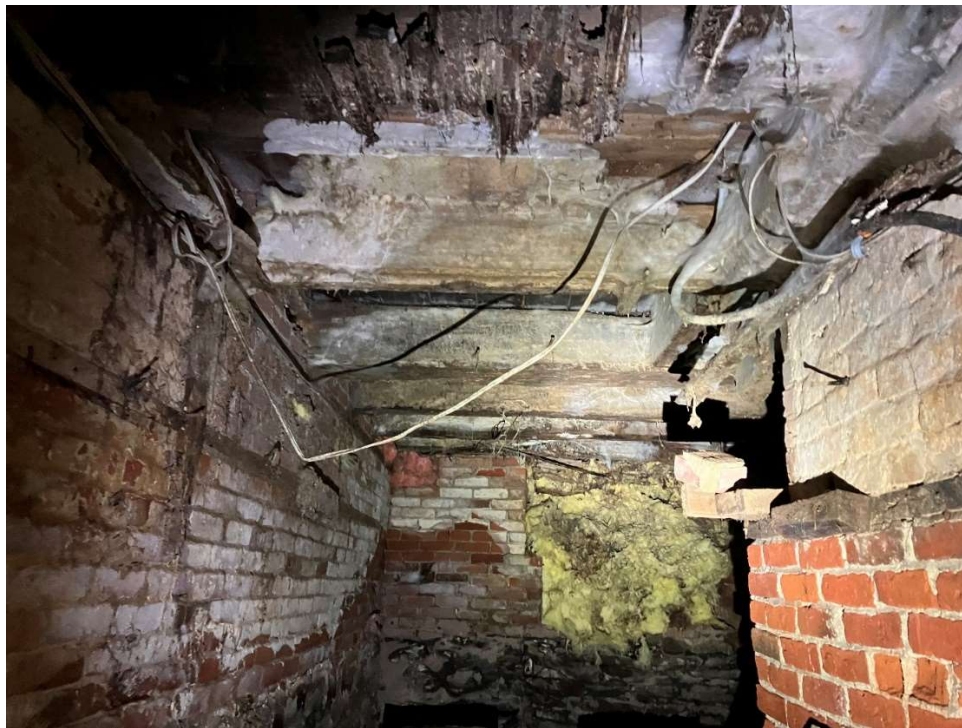
Figure 2-3: Floor Beams

Rough cut mass timber beams span east-west from exterior foundation walls with in-fill beams supporting rough cut wood floorboards. The floor beams bear on a wood sill plate and the rim cavity is in-filled with masonry brick between beams. A consistent white fuzzy growth, noted as mildew, covers approximately 50% to 75% of the framing member's surface area.

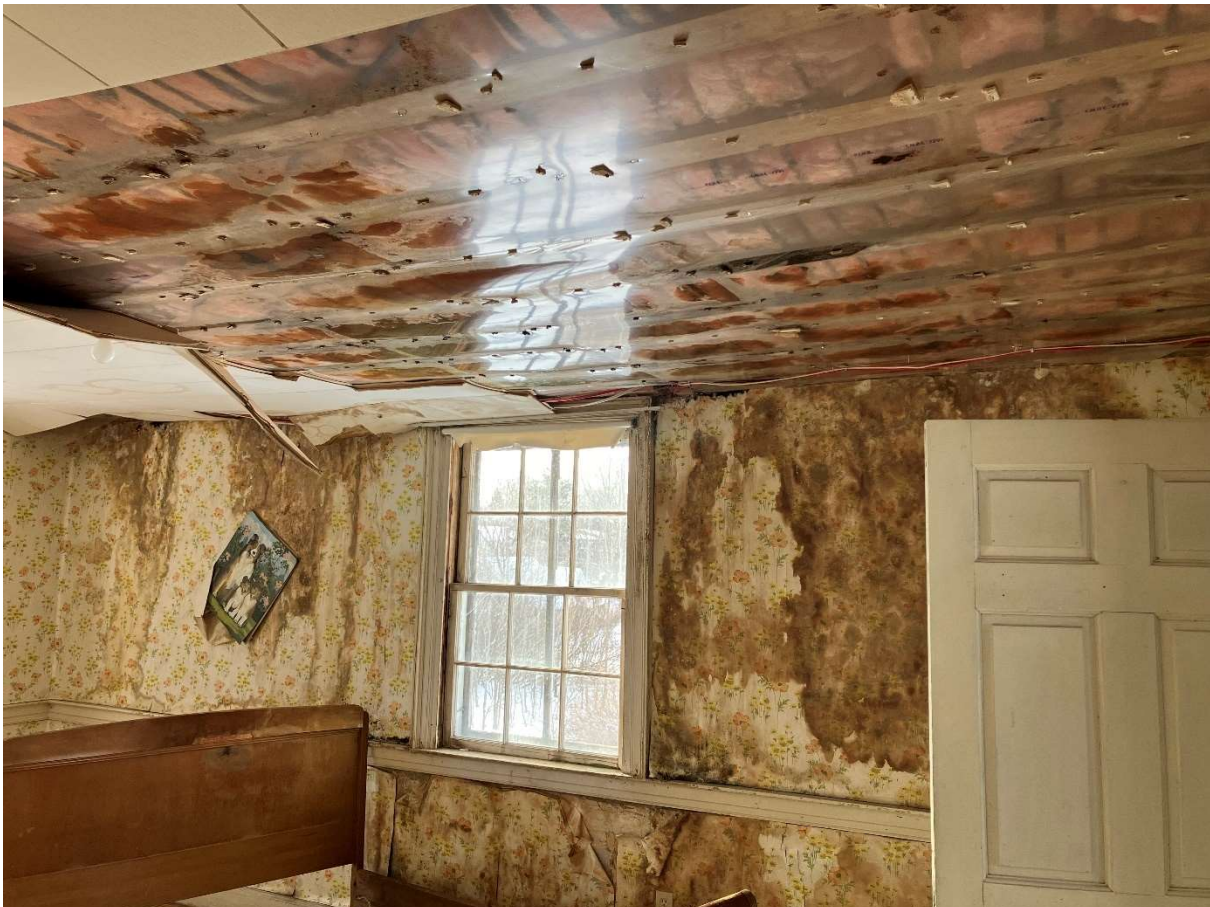
Figure 2-4: General Interior Condition

The main level consists of a bathroom, kitchen, living space, hallway, and staircase. The walls are finished with lath and plaster throughout. Several walls are covered with wallpaper. Sagging/uneven floors, cracking wall and ceiling finishes, signs of water damage, mold, mildew, and a musty damp smell are observed throughout. Various signs of exterior elements can be observed within the house including signs of debris, snow, ice, water, rodents, and insects.

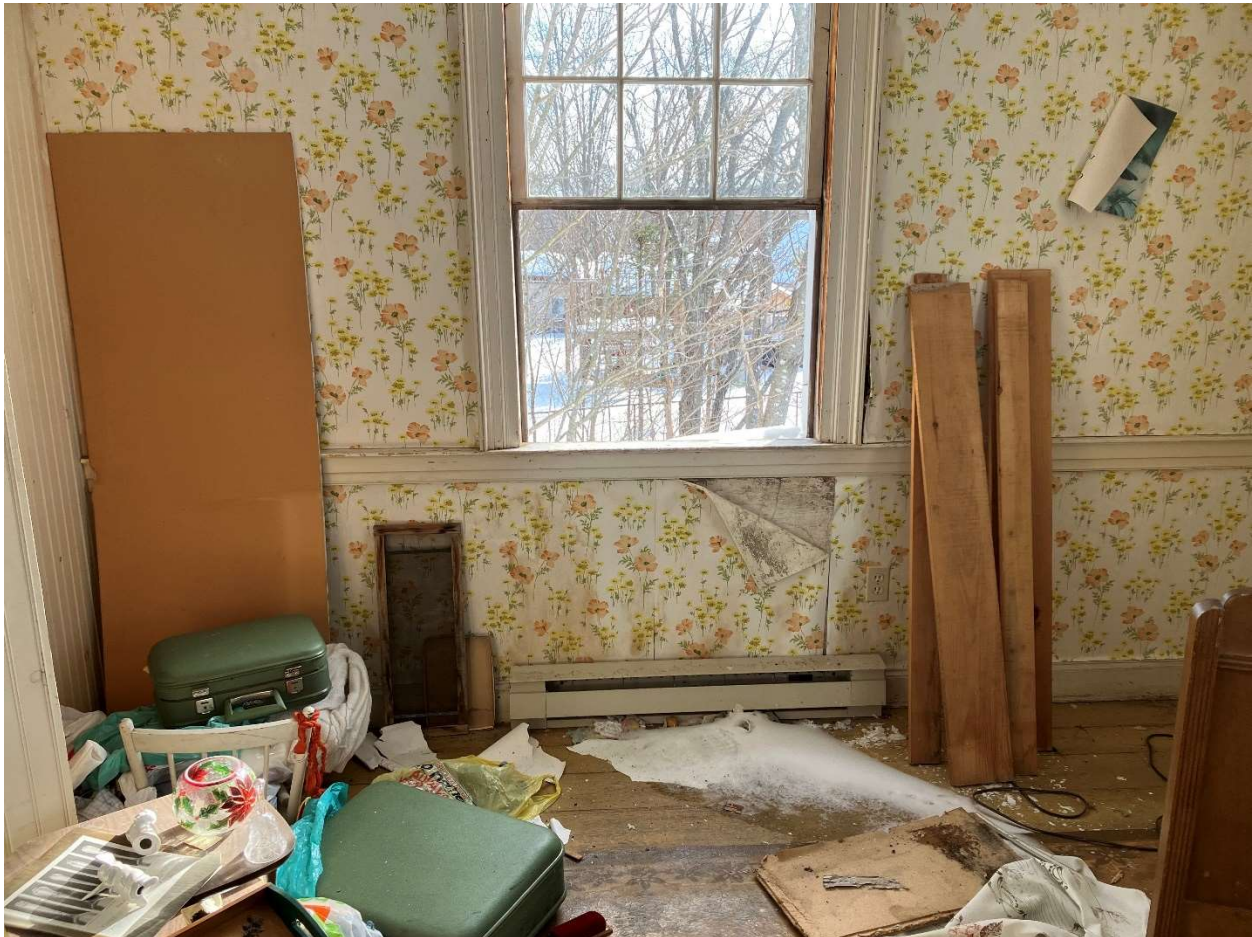
Figure 2-5: Broken Windowpane

The upper level consists of bedrooms, closets, a hallway, and a staircase. Significant amounts of water damage are observed. Wall and ceiling finishes have collapsed or are hanging off the

framing members. Broken windowpanes in multiple bedrooms has left the interior exposed to the exterior elements (see Figure 2-5).

There are several upper-level windows that have damaged or missing glass panes. This has left the interior exposed to the elements and increased the amount of water infiltration. In addition, all windowsills are rotted and deteriorating.

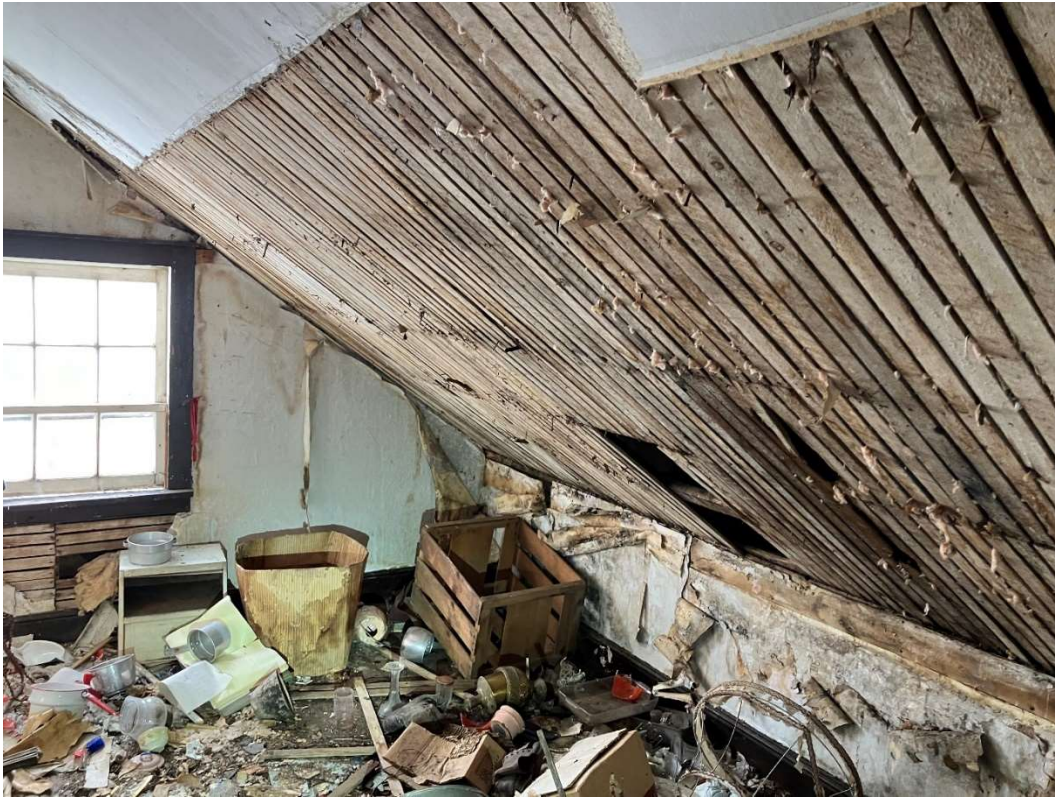
Figure 2-6: General Attic Condition (south east roof slope)

The attic space displays similar signs of deterioration (see Figure 2-6). The ceiling plaster in some areas has completely fallen away from the lath due to water infiltration. Exposed roof framing shows that the roof system is rough cut mass timber rafters with perpendicular roof boards and no insulation. The ridge connection is formed by a mortise and tenon joint with a single peg (see Figure 2-7).

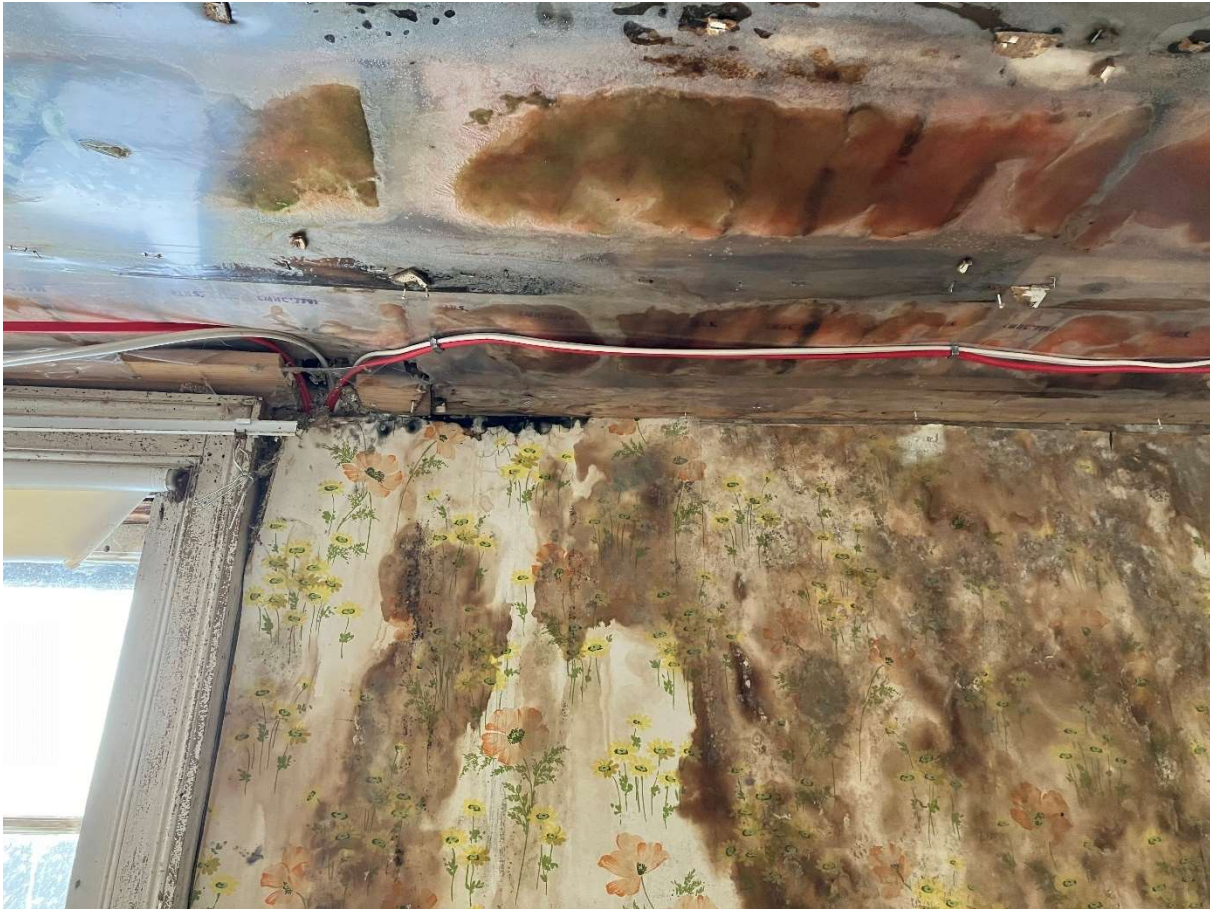
Figure 2-8: Trapped water within ceiling/ floor

The underside of the upper-level floor framing has been built down with dimensional lumber and filled with batt insulation (see Figure 2-4 and Figure 2-8). Strapping and vapour barrier have also been installed. It appears the purpose of this modification was to limit heat loss. However, there is no insulation material in the roof framing cavity above the attic living space. The installed strapping and vapour barrier below the floor framing has acted as a membrane and contained water within the floor system. Wall cavity insulation details were not captured during this inspection due to access. However, it is assumed that there is little to no insulation within the wall assembly.

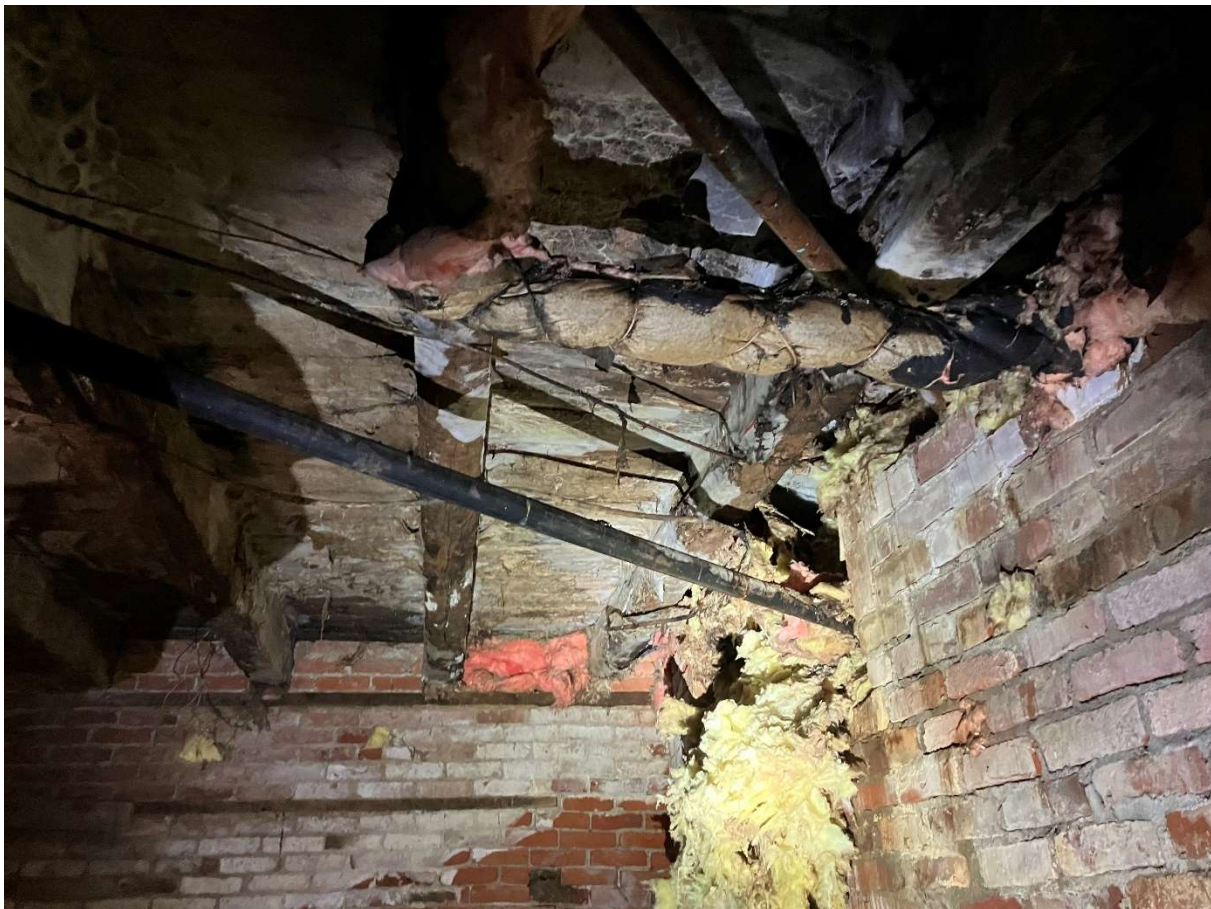
Figure 3-1: Floor Framing

The main load carrying beams, infill beams, and underside of floorboards have visible layers of mildew growing on 50% to 75% of their surface area. From the significant amounts of visible mildew growth, it is assumed that a considerable amount of member rot has occurred, and the members should be considered compromised. As a result, these members would not be suitable for use in an occupied space or for transportation. This assumption can be verified by extracting member core samples and performing material testing to verify the amount of member rot and subsequent member capacity. It is noted that collection of core samples may result in further deterioration of these members.

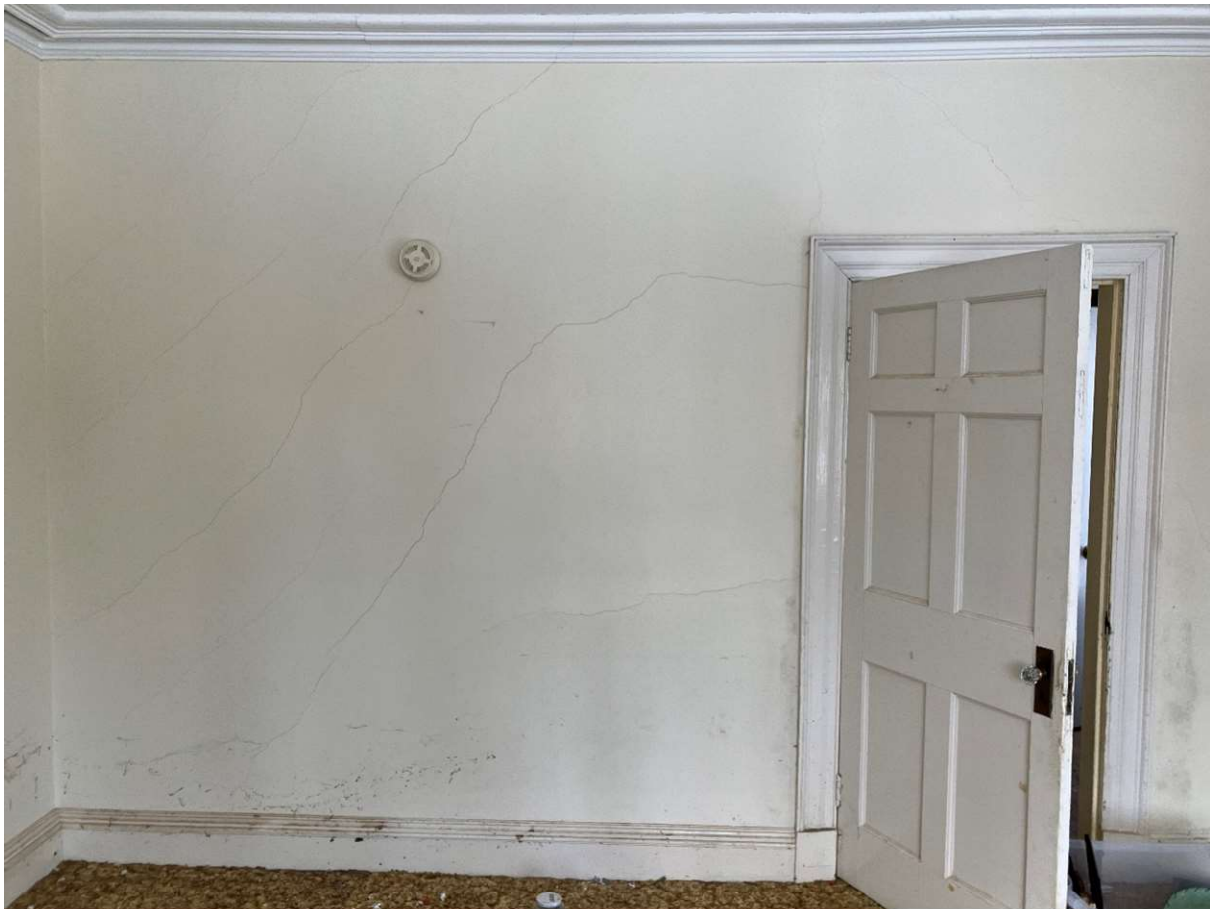
Figure 3-2: Wall Deflection Cracking

The main level floor and center wall orientated in the north-south direction are showing signs of vertical deformation. There are several flexure and shear cracks observed in the wall plaster (see Figure 3-2). Floor settlement is concentrated towards the northern half of the Farmhouse. The supporting floor beams, noted in the previous section, span the entire width of the structure. It appears that the lack of intermediate foundation support below these beams has resulted in the vertical settlement. In addition, these deteriorating conditions have been compounded by the multiple years of neglect due to unoccupancy.

In the same fashion, the upper-level floor framing and partition walls are experiencing vertical deformation. In essence, this is a result of the main level floor beam deflection as noted above.

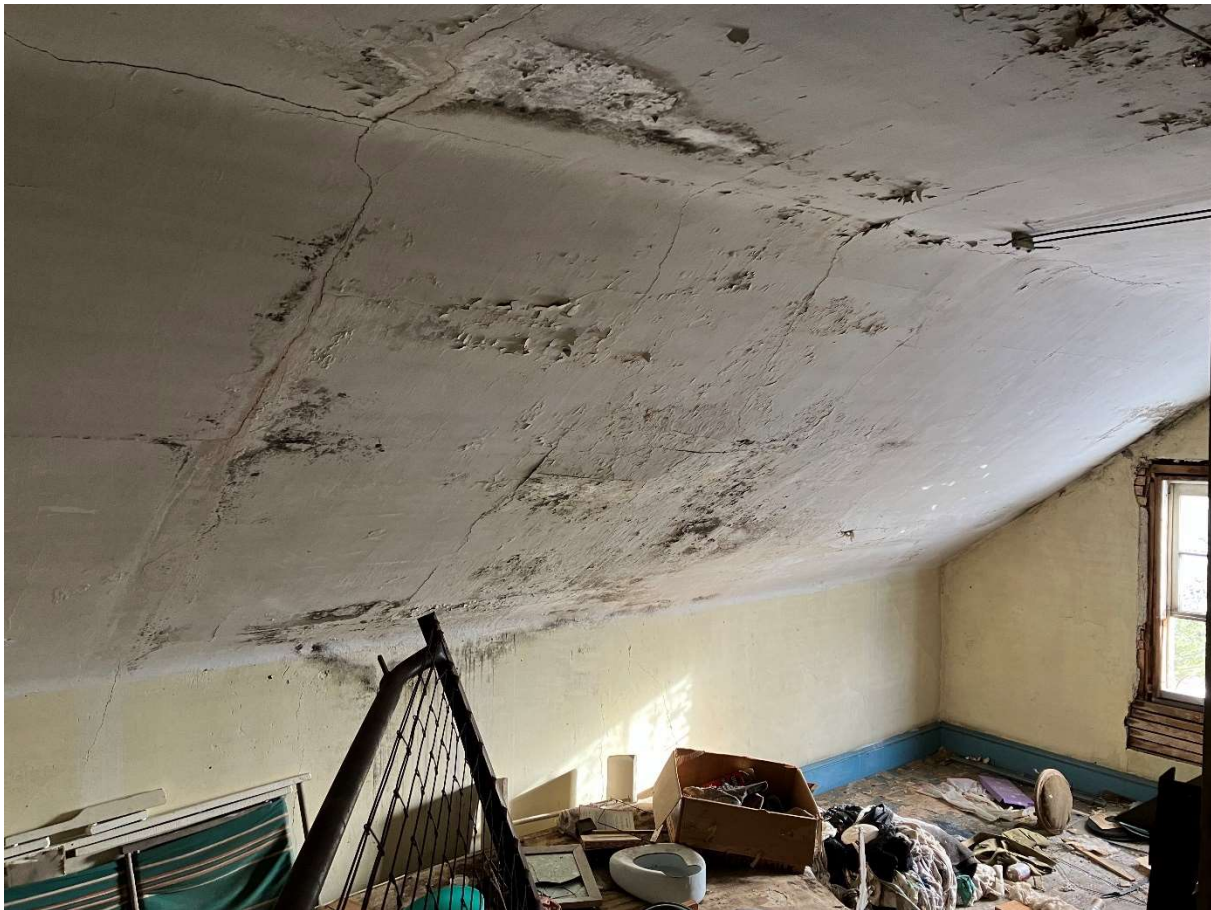
Figure 3-3: Ceiling Water Damage (south west roof slope)

The southeast corner of the Farmhouse has significant water damage observed from the roof down to the main level floor system. The water damage attributes indicate water infiltration has occurred over several years with considerable water staining, mildew, mold, and rotting of structural members. Large sections of the interior plaster and wallpaper finishes have collapsed or are damaged. In addition to Figure 3-3 below, see Figure 2-4: General Interior Condition.

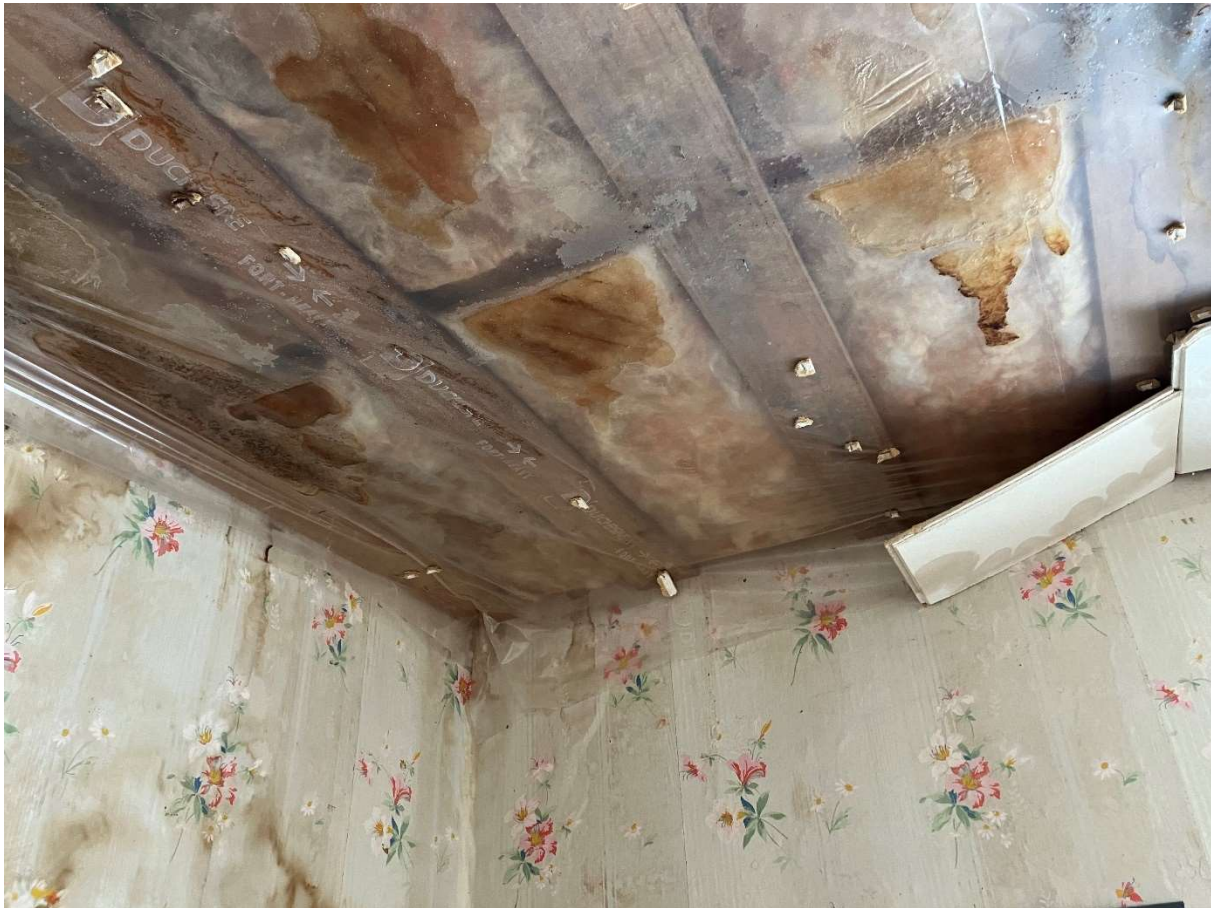
Figure 3-4: Water damage in floor & ceiling assembly

A subsequent renovation estimated to have been undertaken in the 1970's (based on manufacturer's date stamp on vapour barrier) included the installation of batt insulation, vapour barrier, and strapping along the underside of the original second storey and attic floor framing (see Figure 2-4, Figure 2-8, and Figure 3-4). This system resulted in the trapping and pooling of infiltrated water around and against the existing framing. This pooling and trapping effect increases the magnitude of mold, mildew, and rot within the structural members.

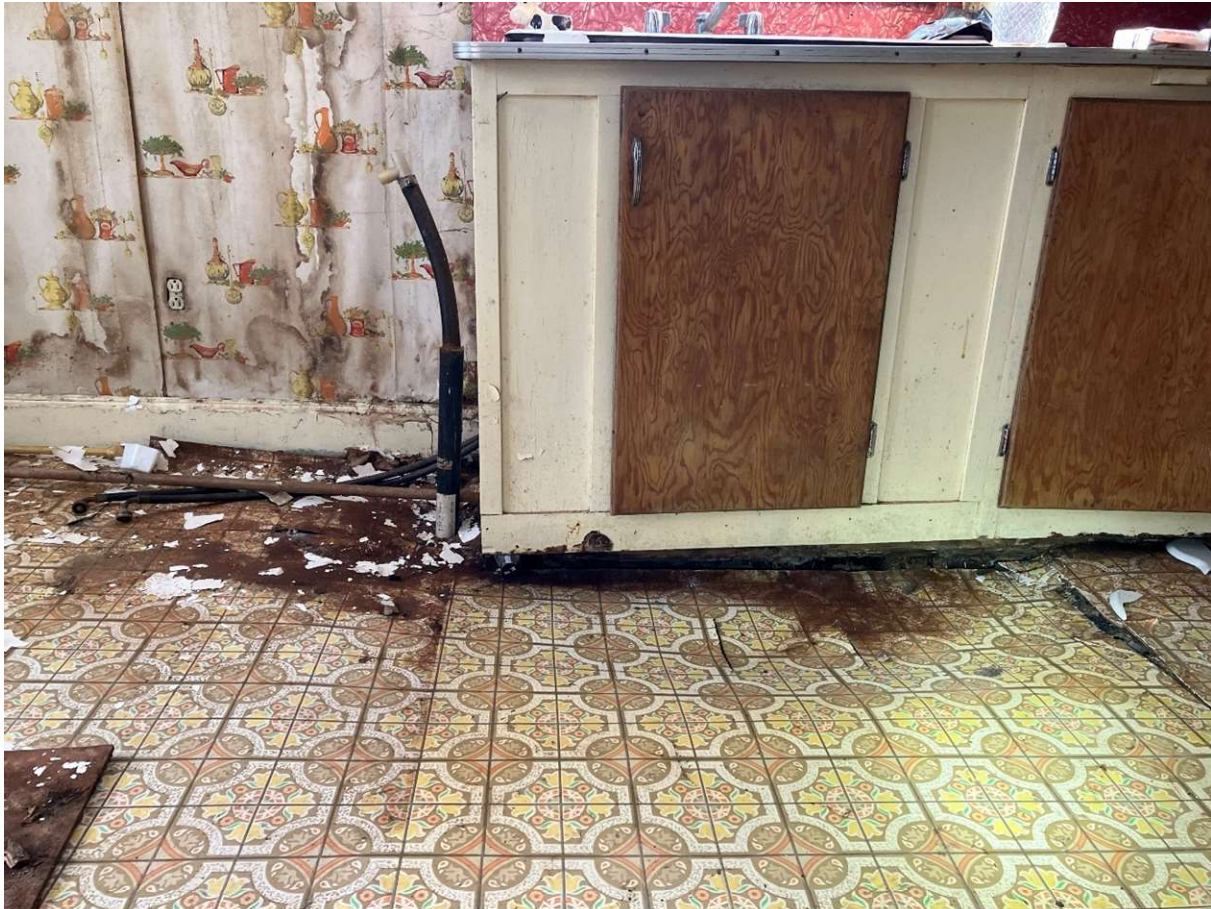
Figure 3-5: Kitchen floor failure

Within the kitchen area, the water infiltration has resulted in significant rotting of the floor beams, floorboards, sill plate, and exterior framing (see Figure 3-5). As a result, a portion of the kitchen floor has collapsed and is currently covered with a piece of plywood (note, the plywood was temporarily removed and replaced for inspection).

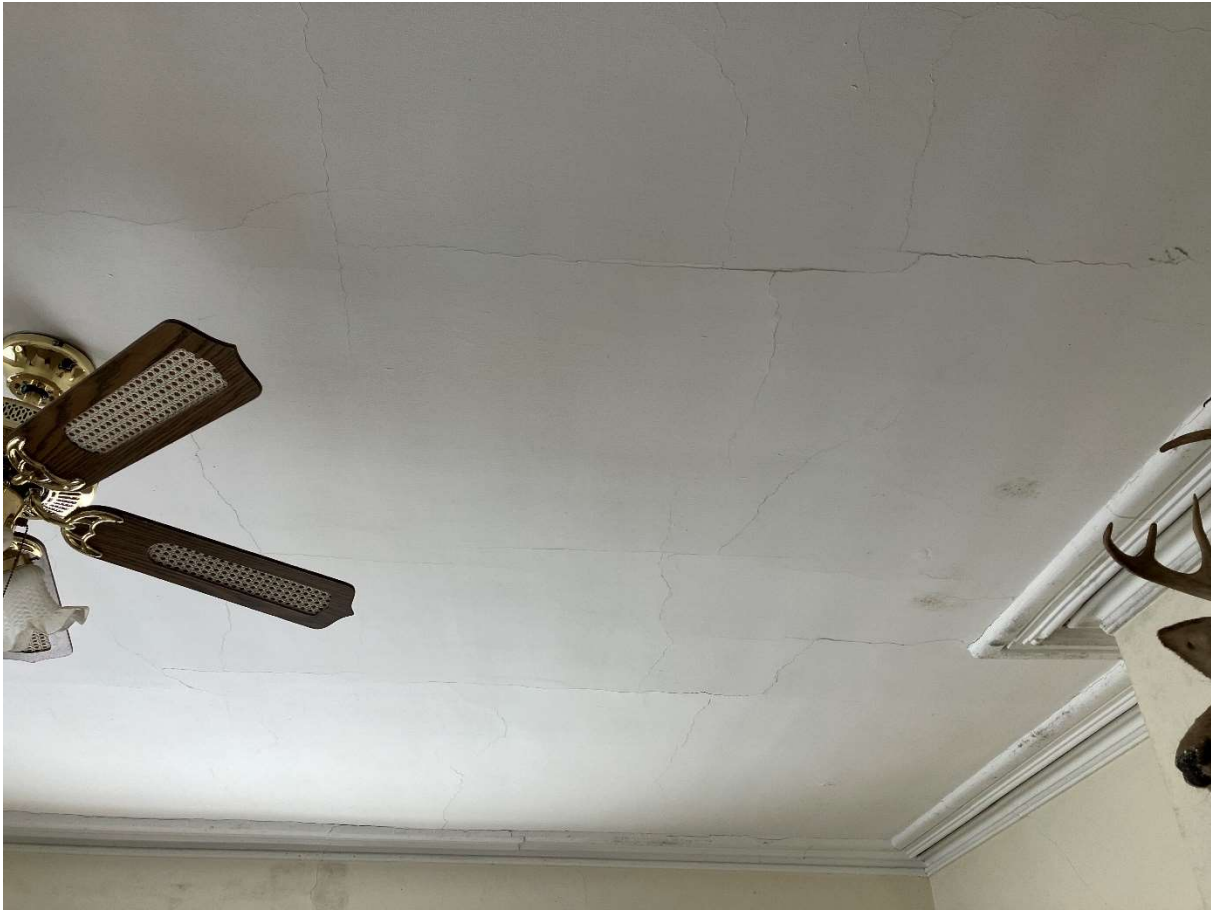
Figure 3-6: Ceiling Cracks

Hairline to large cracking of ceiling and wall plaster is noted throughout the Farmhouse. Given the size, pattern, and location of cracks, it appears the cracks are the direct result of inadequate structural support, structural settlement, water damage to framing members, and fluctuations in member geometry due to temperature changes. As previously noted these deteriorating conditions have been compounded by the multiple years of neglect due to unoccupancy.

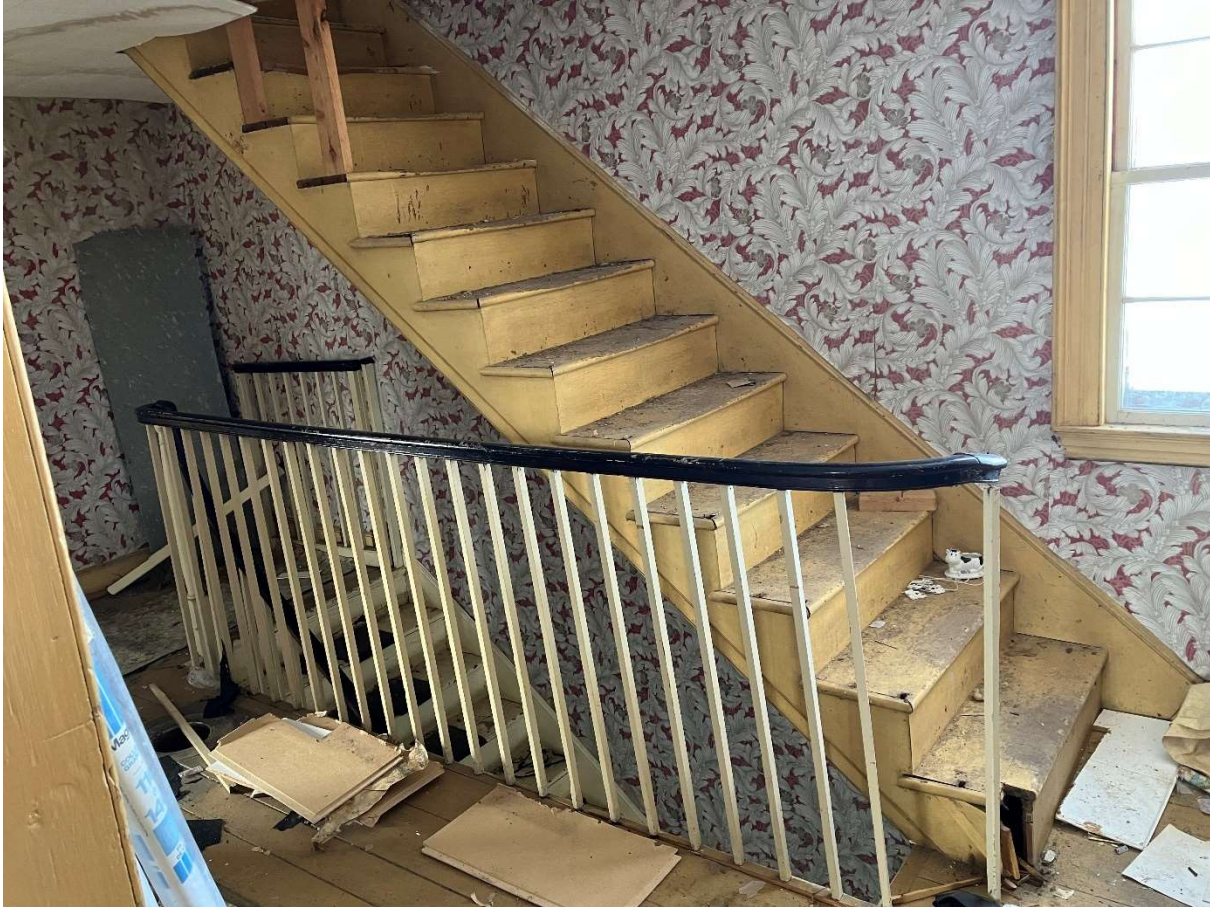
Figure 3-7: Typical Stair & Handrail Condition

The existing stairs do not satisfy National Building Code of Canada requirements. Including rise, run, clear height above nosing, minimum handrail height, guards, and minimum strength. Portions of the stair framing is damaged; handrails are damaged or missing.

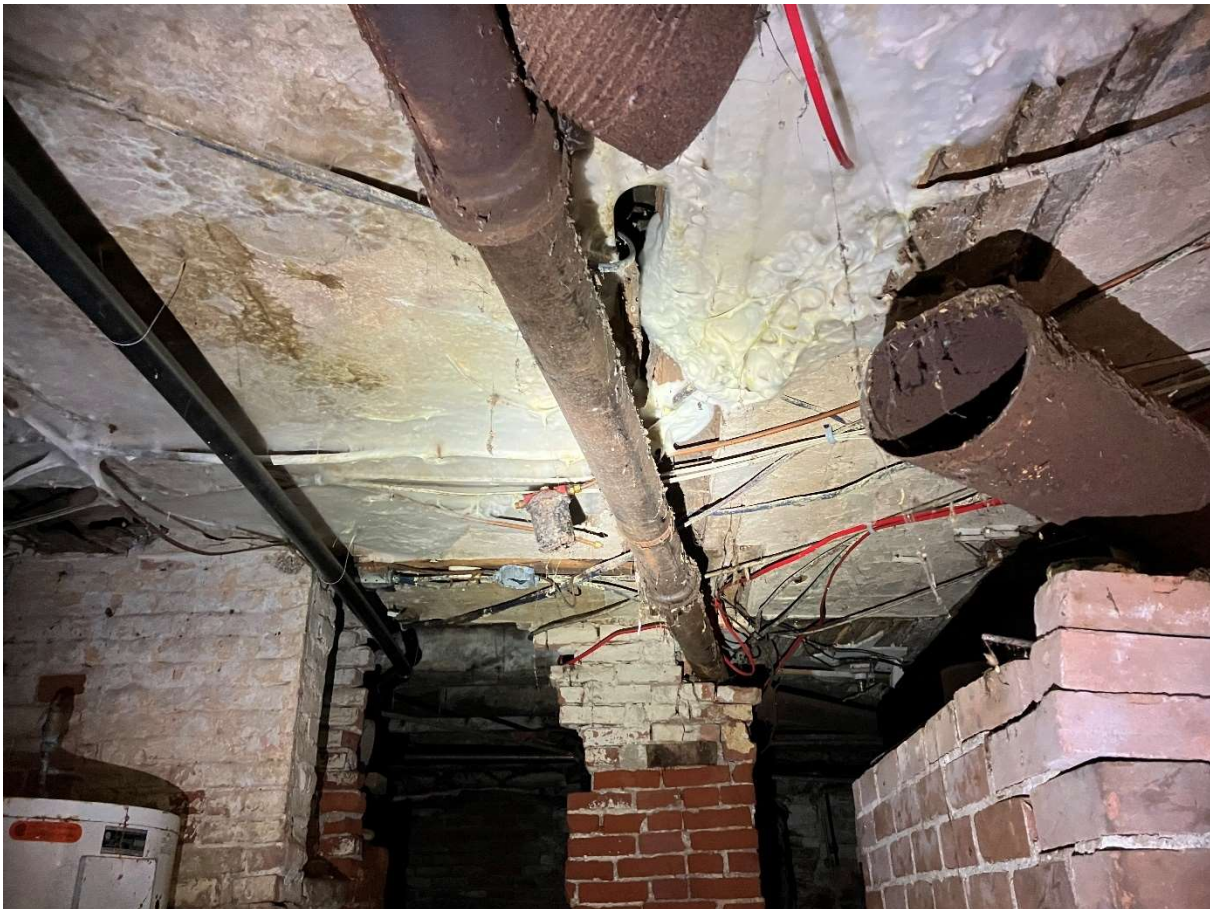
Figure 3-8: Typical Electrical & Plumbing Condition

In addition to failed or damaged infrastructure, the electrical and plumbing utilities do not satisfy National Building Code of Canada requirements. Including but not limited to exposed wires, improper use of junction boxes, undersized drainpipes, insufficient or inaccessible cleanouts, incorrect venting, poor drainpipe slope, etc.

Since the interior has been exposed to the elements with no heat throughout the winter months it is assumed that water pipes may have been compromised due to expanding ice pressures.

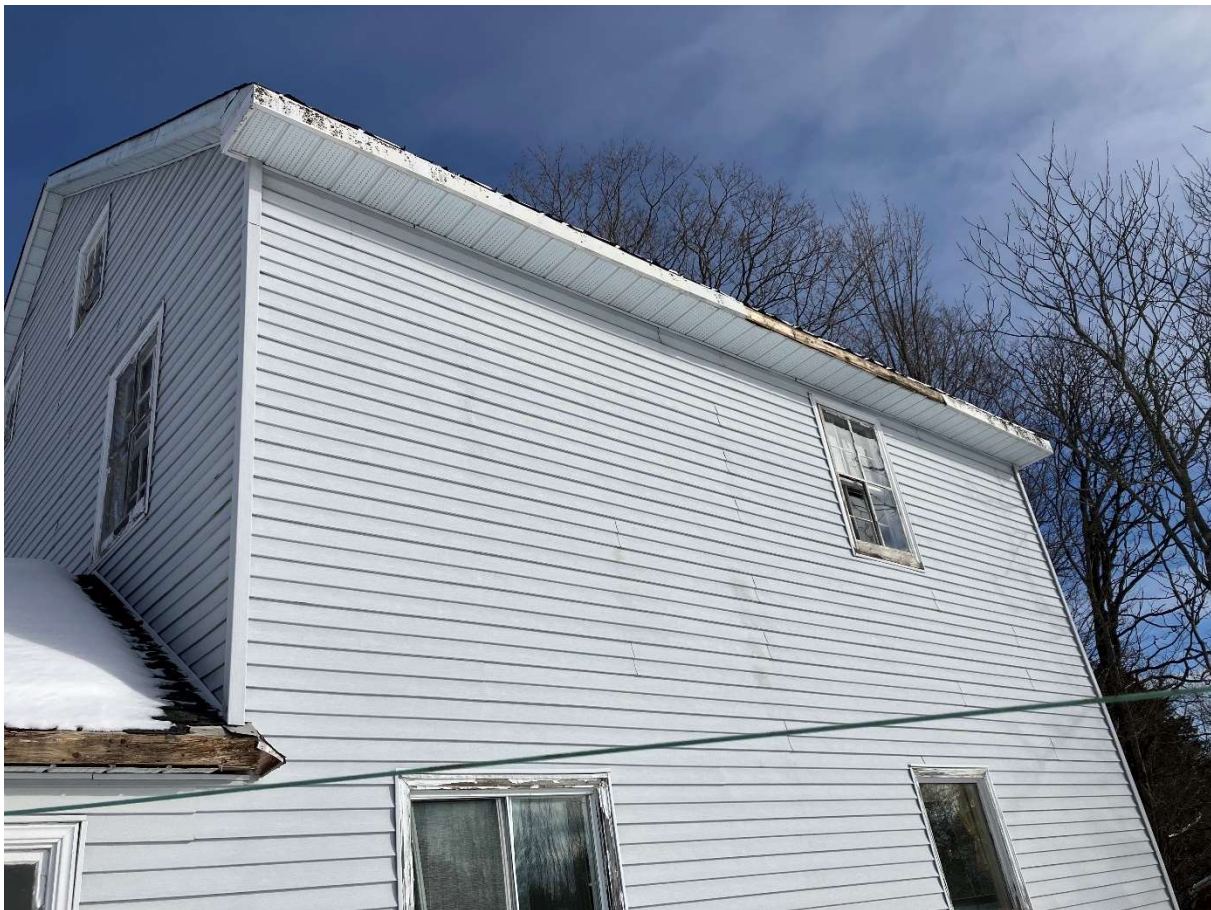
Figure 3-9: Flashing Failure

Existing eave and gable end flashing around the roof perimeter has failed and become detached from the Farmhouse. This failure exposes the framing and interior components of the structure to the elements. This includes unwanted water, rodent, and pest infiltration.

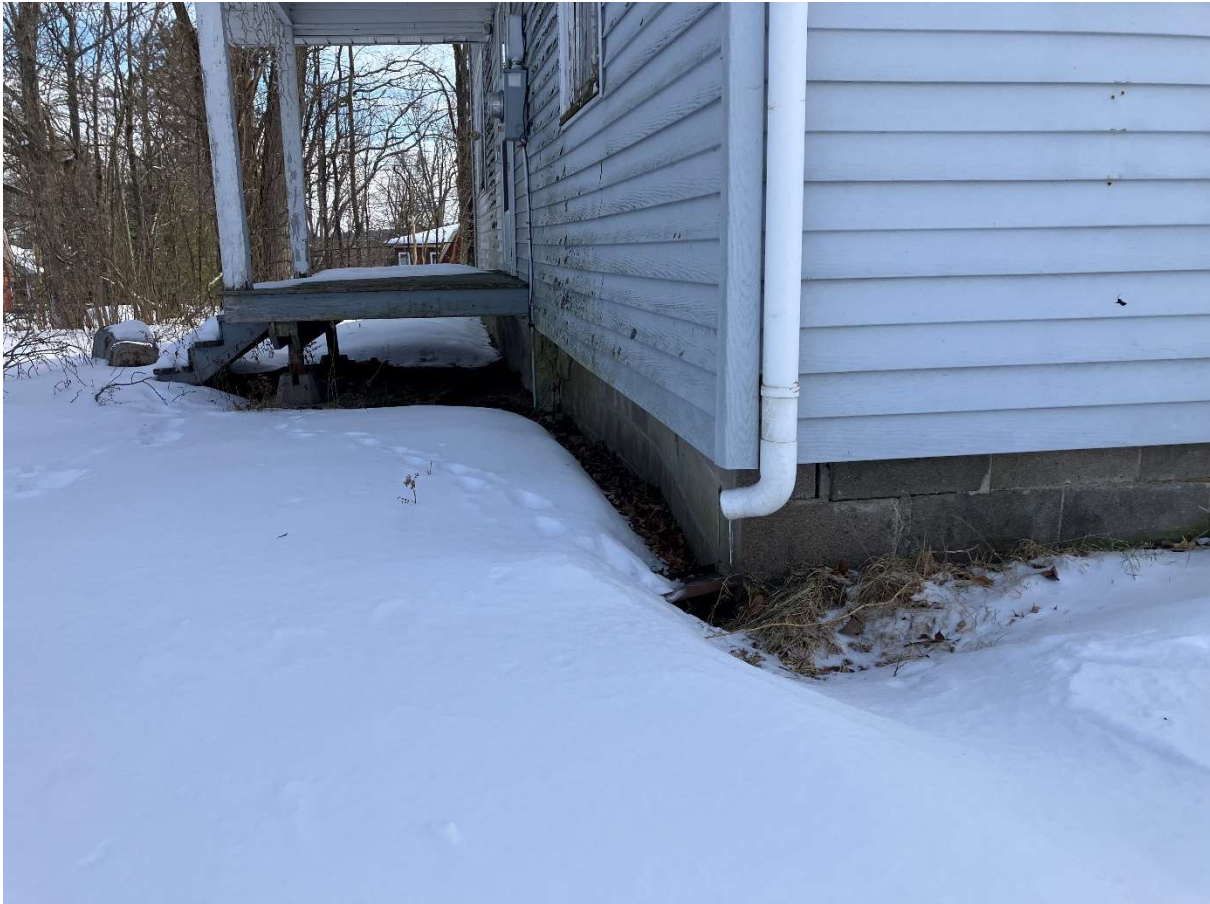
Figure 3-10: Porch Foundation Wall Failure

On the west side of the Farmhouse there is an enclosed porch with a hip styled roof, 5 windows, 1 door, and exterior vinyl siding. The interior is unfinished with wood joists, subfloor, and rafters. The foundation is masonry block wall with an open basement below the floor joists. The porch structure appears to be constructed after the original Farmhouse structure was built. The north foundation wall of the porch has partially failed and is collapsing inwards.
