**Marysville Flats Property  
PID 75457440**

**BASELINE DOCUMENTATION REPORT**

**Dated as of December 8, 2021**

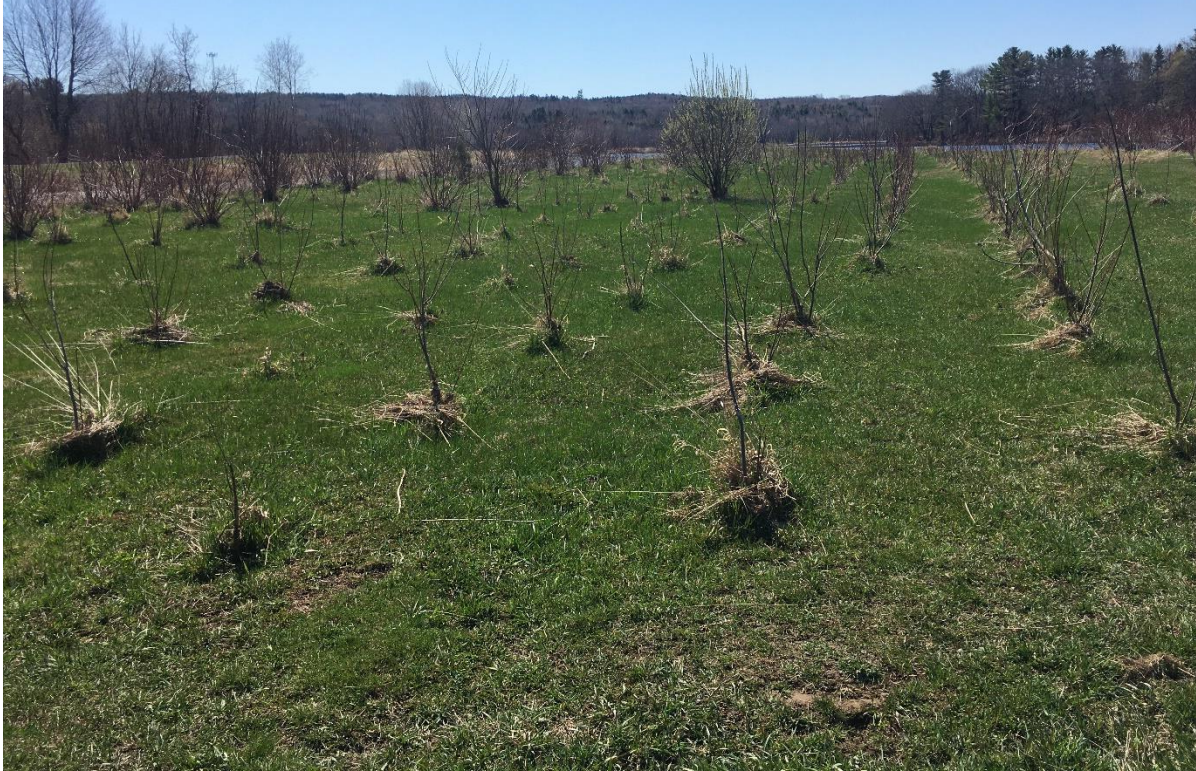
A01a. Anthropogenic Grassland (planted Floodplain Forest). Taken on May 6, 2020 at 11:25am.

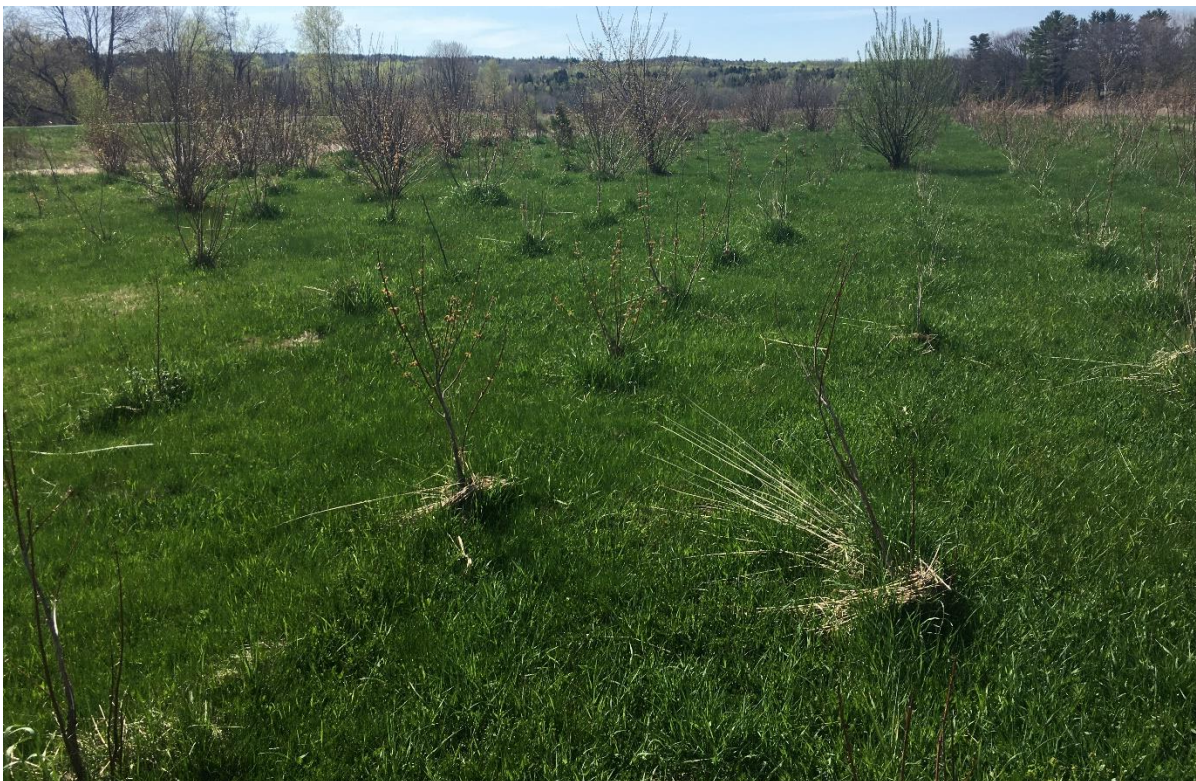
A01b. Anthropogenic Grassland (planted Floodplain Forest). Taken on May 21, 2020 at 10:36am.

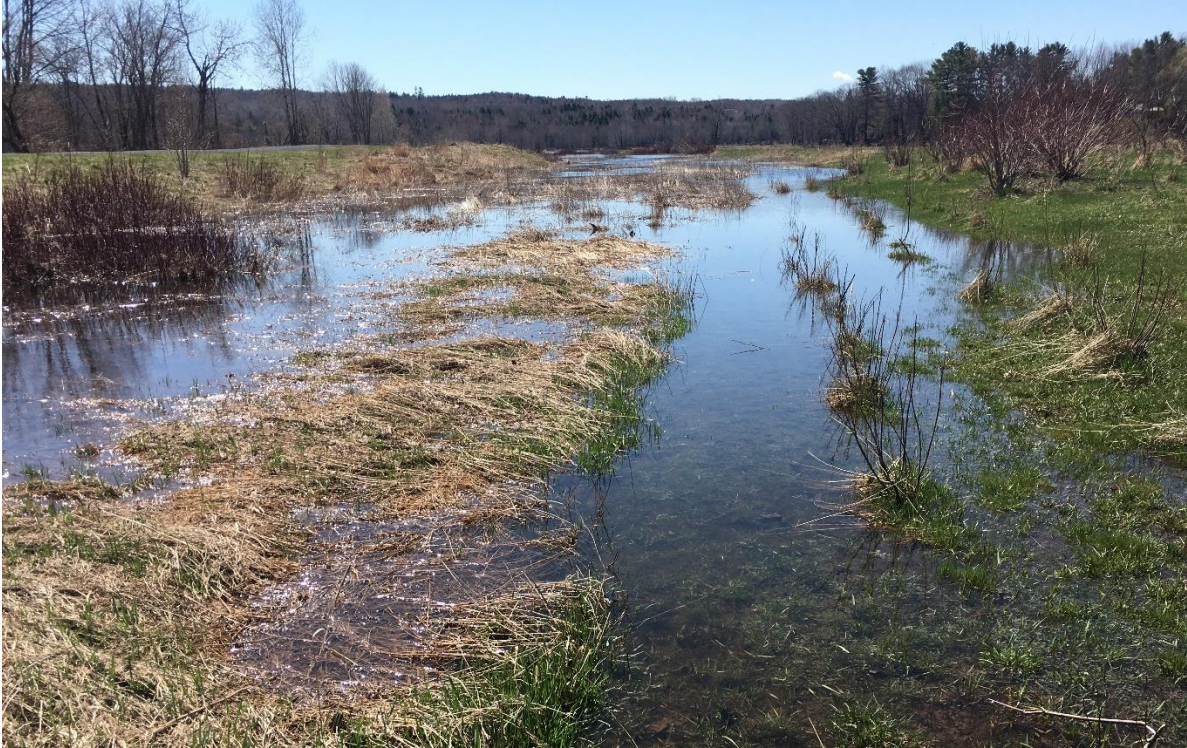
A02a. Anthropogenic Grassland (Backwater Swale during flooding). Taken on May 6, 2020 at 11:30am.

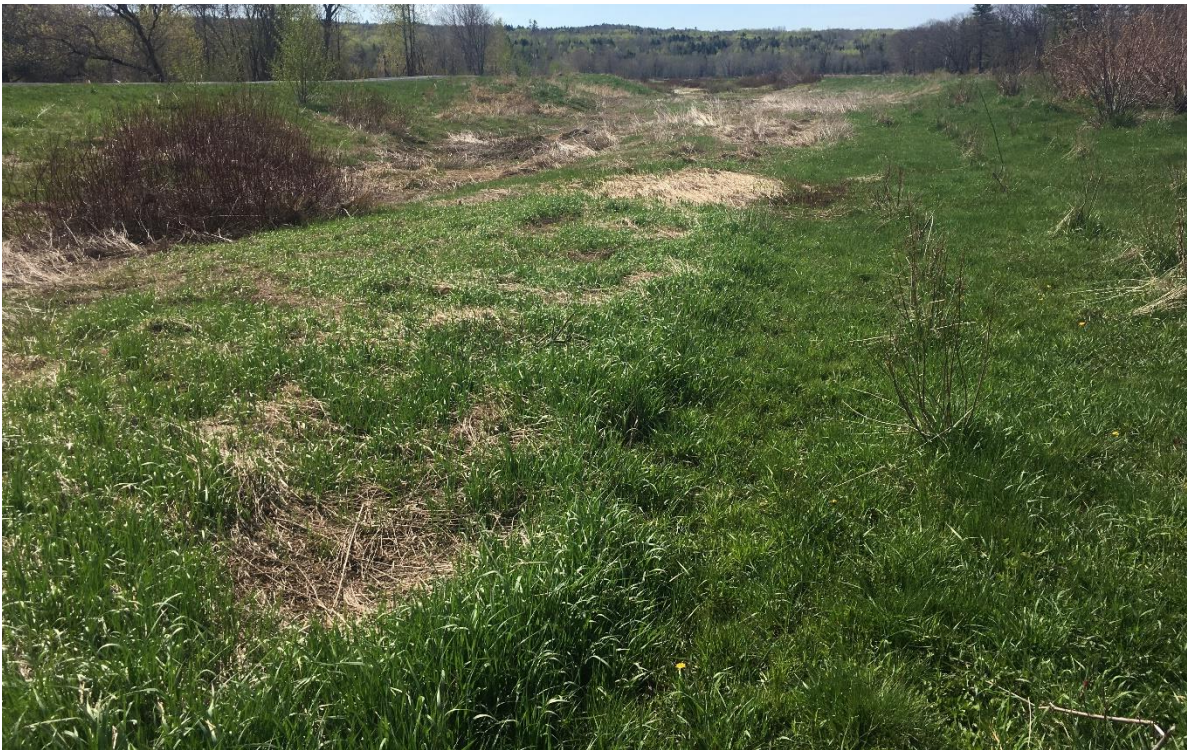
A02b. Anthropogenic Grassland (Backwater Swale post-flooding). Taken on May 21, 2020 at 10:37am.

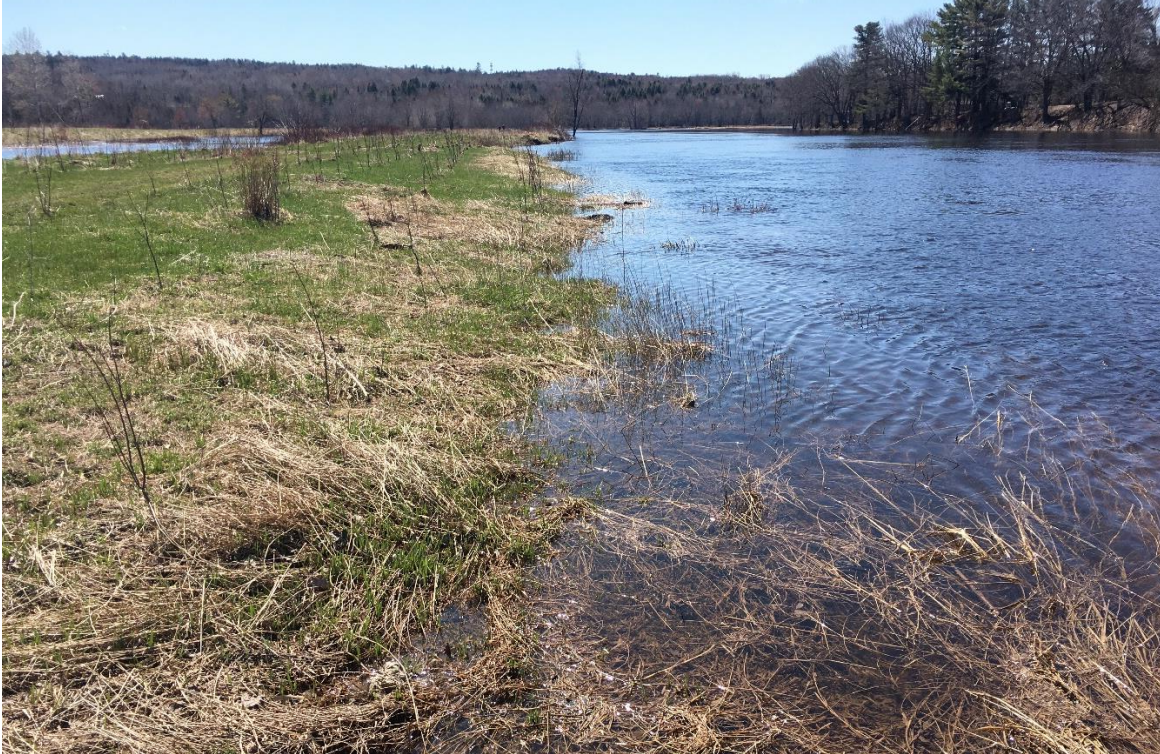
A03a. Anthropogenic Grassland transition to Open Water (**Riverbank** during flooding). Taken on May 6, 2020 at 11:34am.

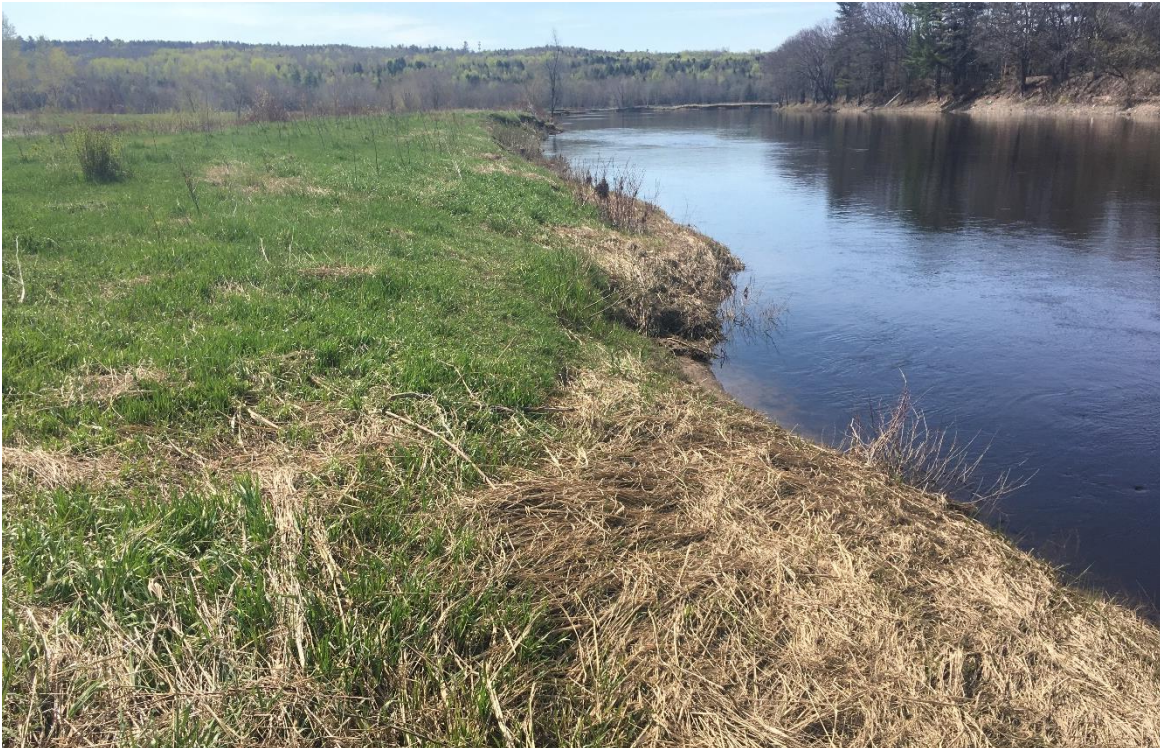
A03b. Anthropogenic Grassland transition to Open Water (Riverbank post-flooding). Taken on May 21, 2020 at 10:39am.

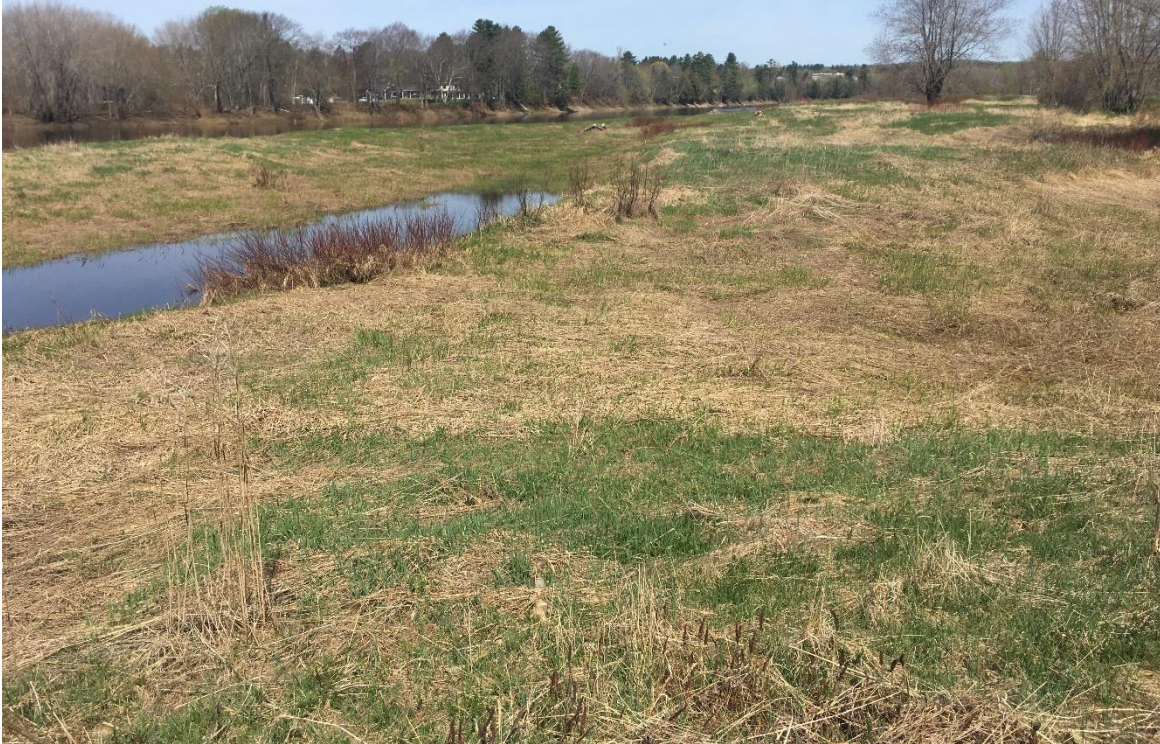
A04. Anthropogenic Grassland (unplanted field and Backwater Swale). Taken on May 21, 2020 at 11:08am.

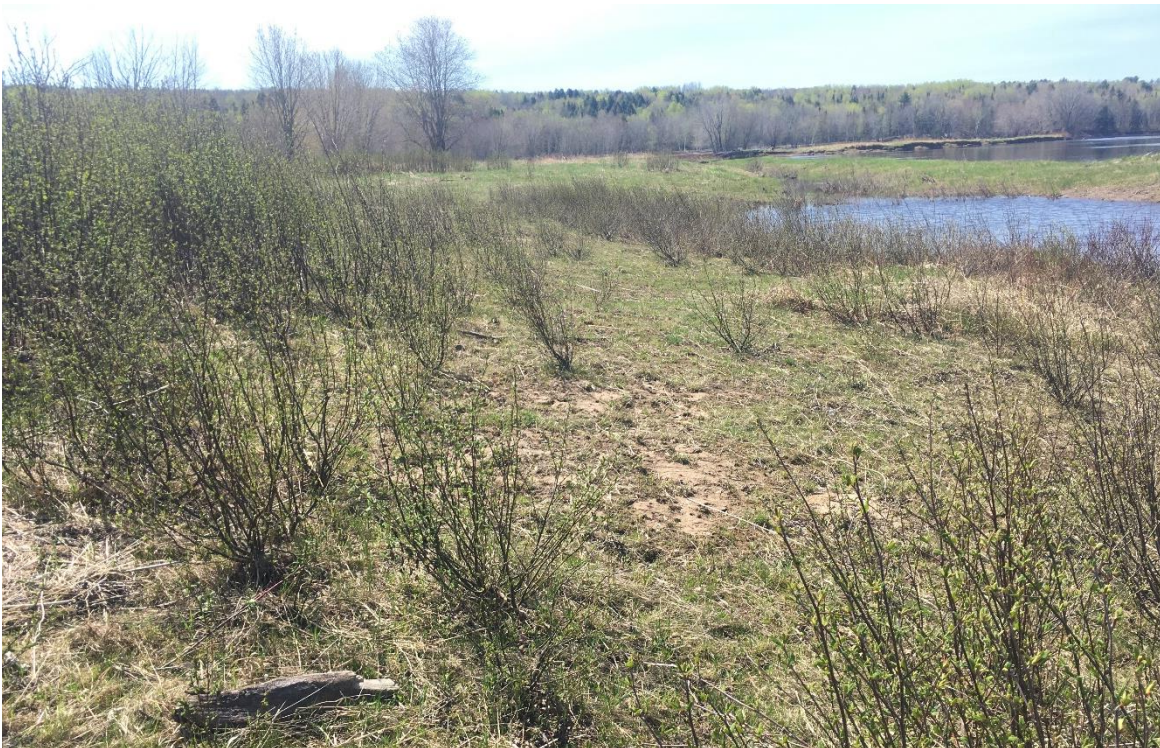
A05. Alders colonizing old construction site. Taken on May 21, 2020 at 11:13am.

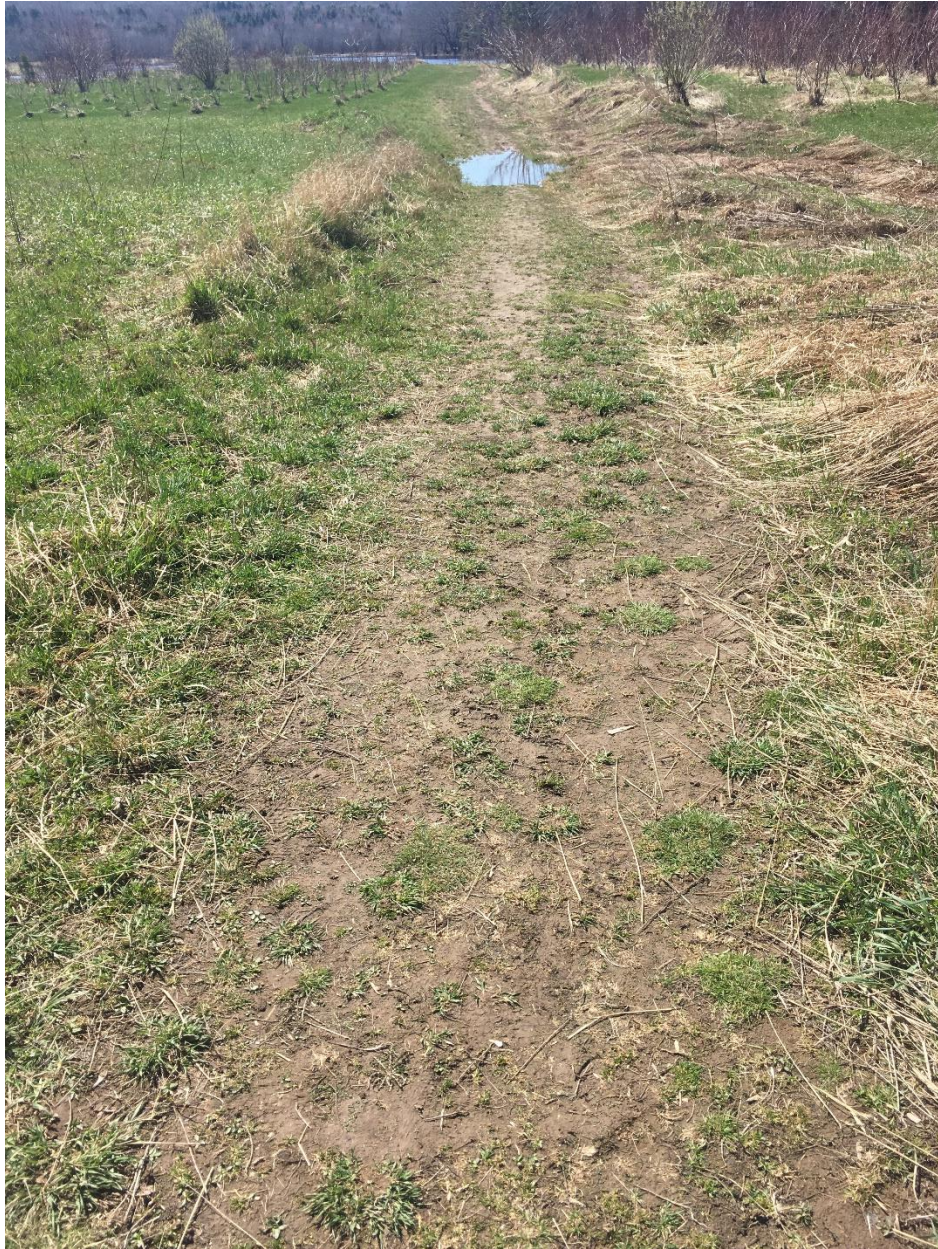
B01. Primary Access Trail. Taken on May 6, 2020 at 11:20am.

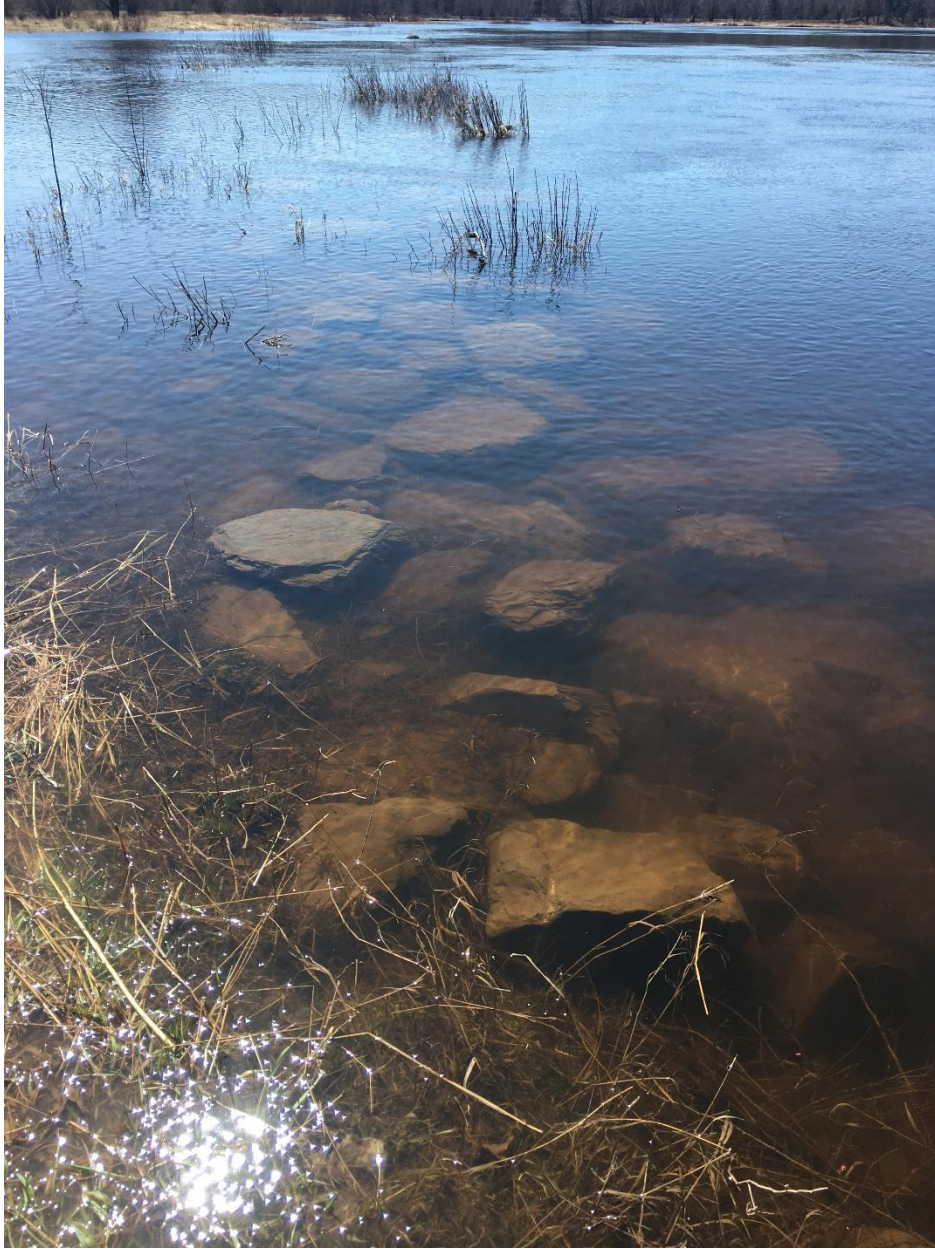
B02a. Rock Armouring. Photo taken during flooding on May 6, 2020 at 11:39am.

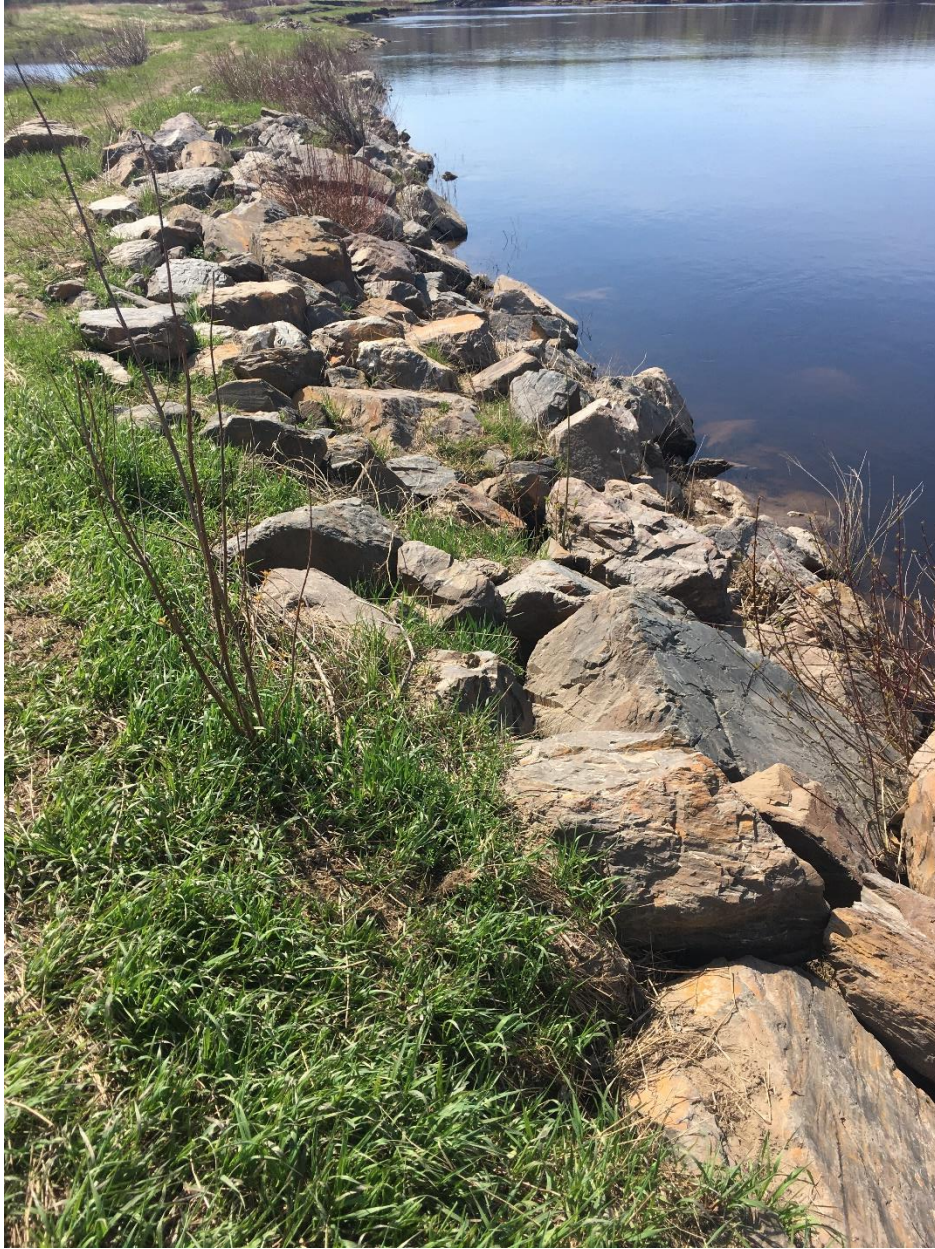
B02b. Rock Armouring. Photo taken post-flooding on May 21, 2020 at 10:44am.

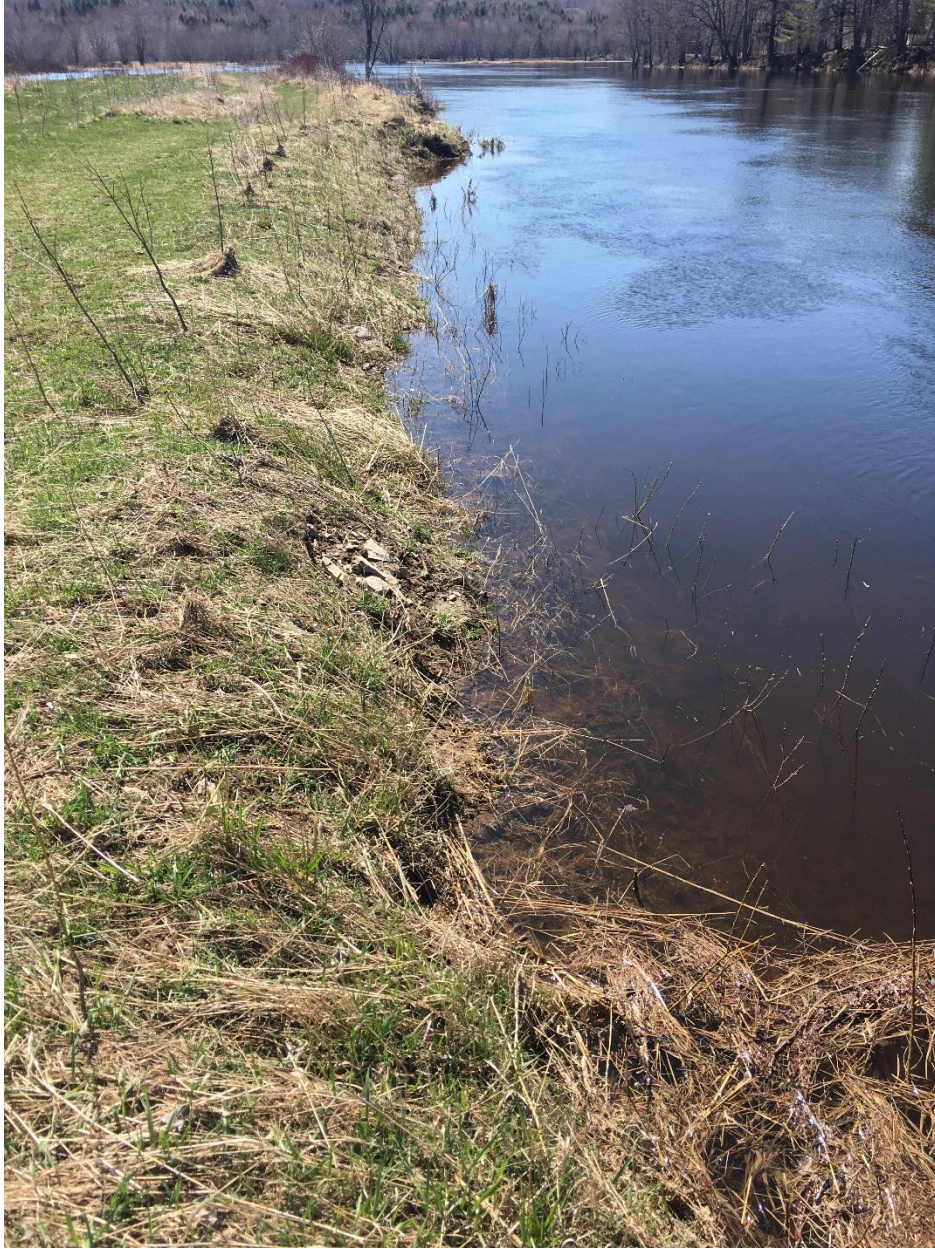
B03a. NWA bank stabilization project. Photo taken during flooding on May 6, 2020 at 11:43am.

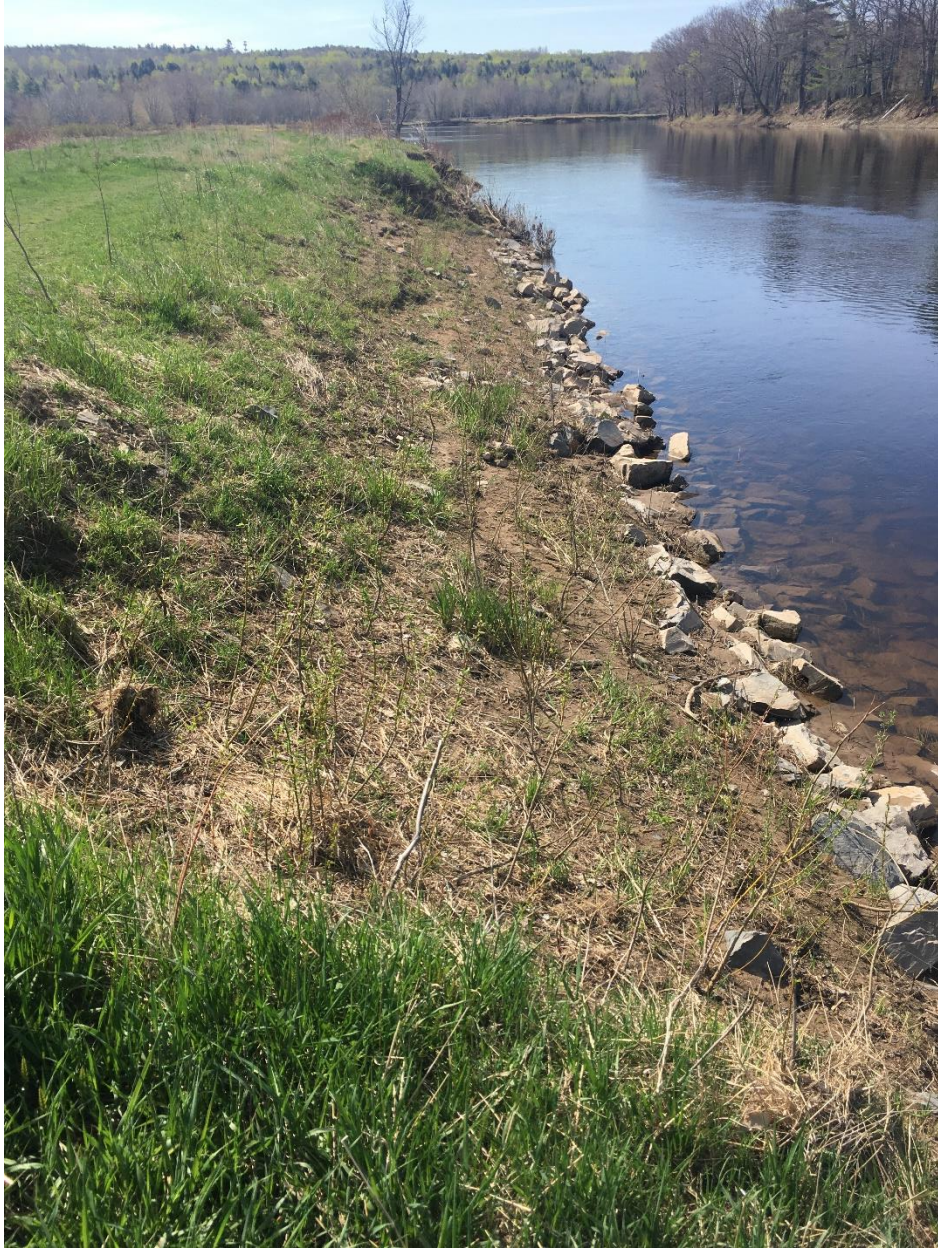
B03b. NWAI bank stabilization project. Photo taken post-flooding on May 21, 2020 at 10:40am.

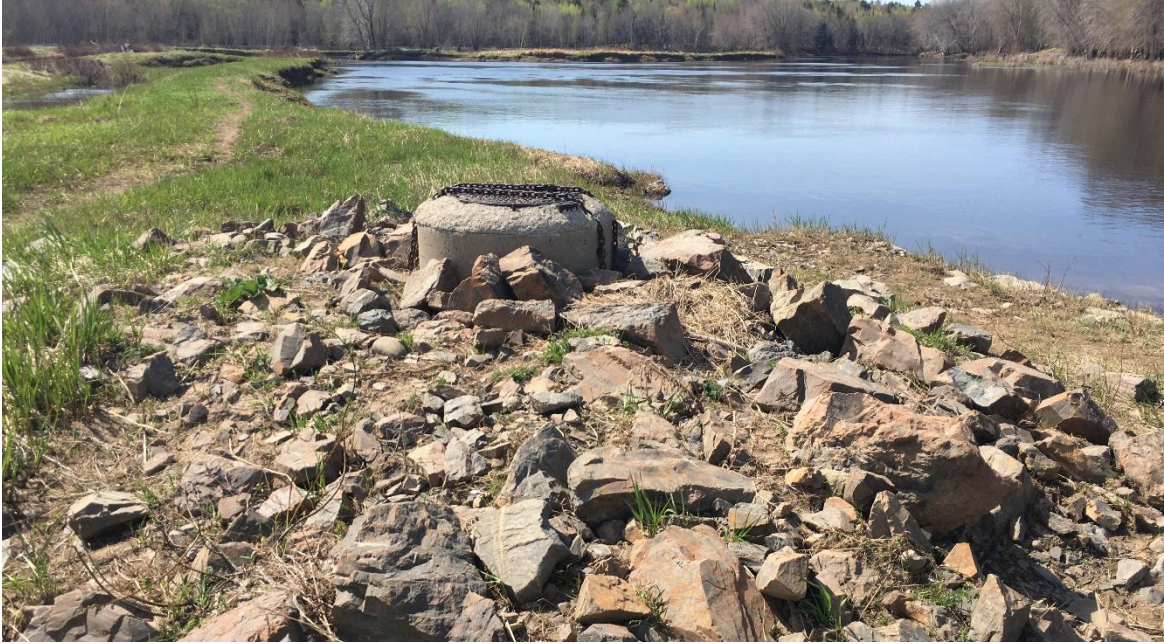
B04a. Storm drain. Photo taken on May 21, 2020 at 10:46pm.

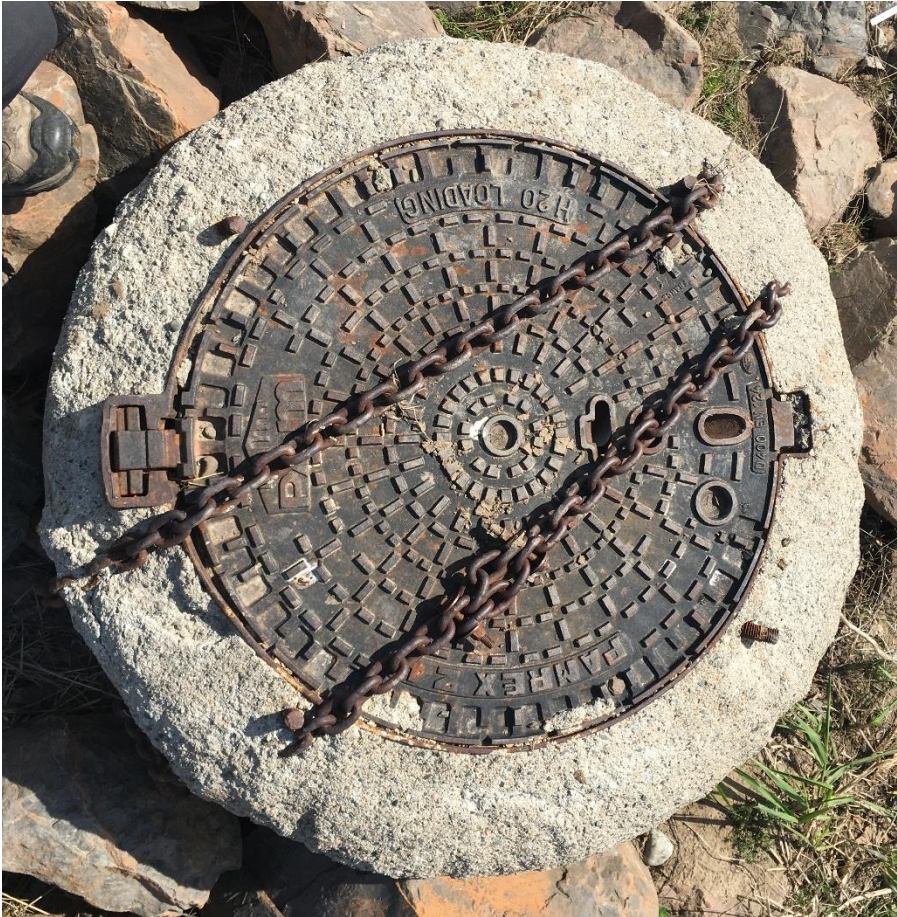
B04b. Storm drain. Photo taken on May 21, 2020 at 10:46pm.
