**Marysville Flats Property  
PID 75457440**

**BASELINE DOCUMENTATION REPORT**

**Dated as of December 8, 2021**

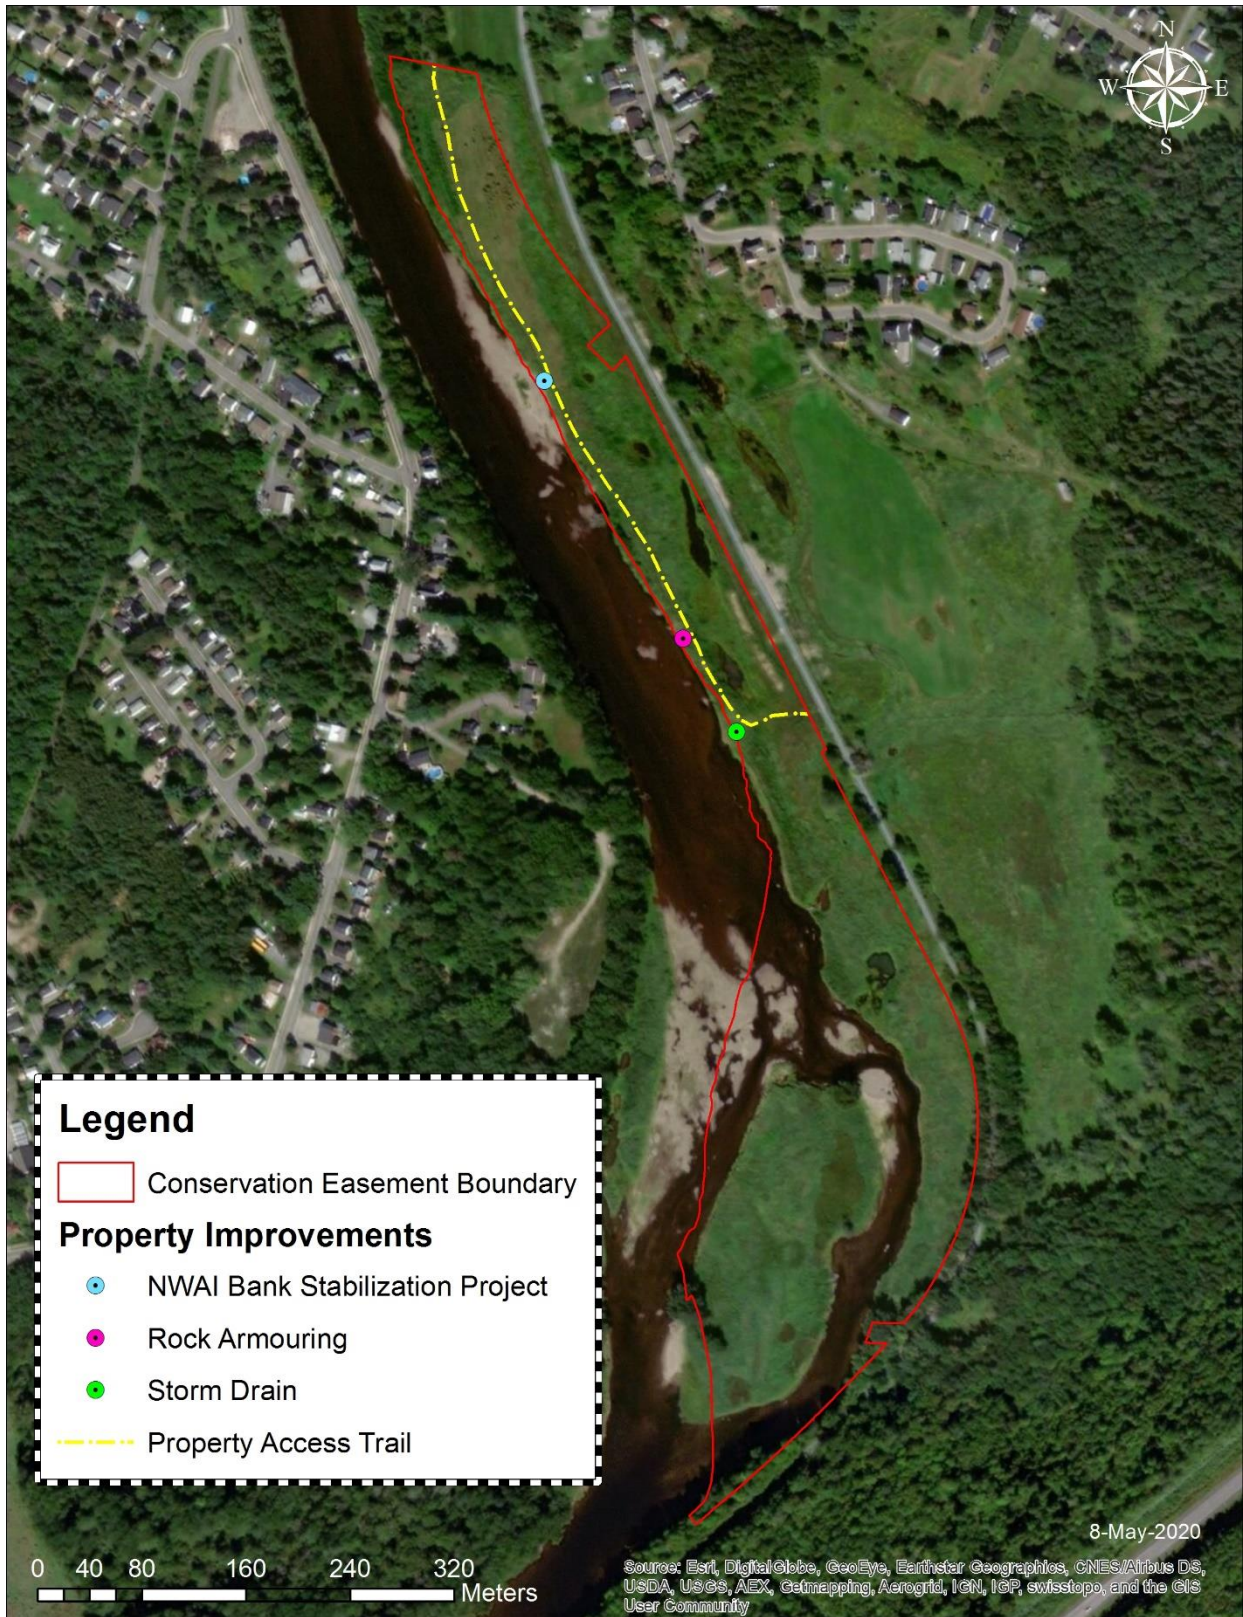
Figure 4. Improvements on the Marysville Flats Property

Measurement and Conditions							
Type	Function	Description	Size	Height	Principle Material	Condition Rating <sup>2</sup>	Spatial Coordinates
<b>Property Improvement<sup>1</sup></b>							
<b>Property Access Trail</b>	Primary access trail to the property	Old farm access road now used as a walking trail and access for machinery used for Ecological Restoration purposes.	Width = 2.5m Length = 618m	N/A	Dirt track	Fair to Good	See Figure 4
<b>Rock Armouring</b>	Rock deposited on riverbank to stop erosion	Large boulders deposited during municipal storm water drainage construction	Approximately 45m of Riverbank	N/A	Rock	N/A	Lat: 45.970979 Lon: -66.587651
<b>NWAI Bank Stabilization Project</b>	Bioengineered bank stabilization	Bank re-sloping, installing geotextile, and planting riparian vegetation to halt erosion	Approximately 30m of Riverbank	N/A	Geotextile fabric	Good	Lat: 45.972831 Lon: -66.589066
<b>Storm Drain*</b>	Sanitary line providing municipal services	Line runs from McGloin Street, down through the subject property, and to a Lift Station on the other side of Nashwaak River at Dodona Place (note: sanitary line and 10 m on either side excepted from Conservation Easement to allow for future required maintenance, removal, etc.)	Diameter = 375 mm	51cm	Steel and concrete	Good	Lat: 45.970338 Lon: -66.587118
